RIFFENBURGH  
ELEMENTARY  
SCHOOL

## FACILITY CONDITION ASSESSMENT

FORT COLLINS, CO

OCTOBER 2023

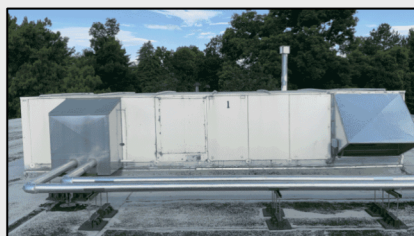
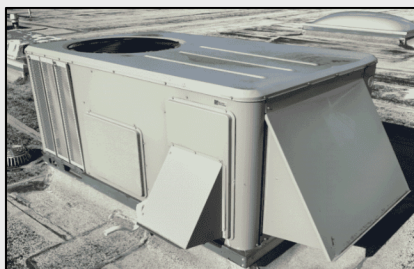
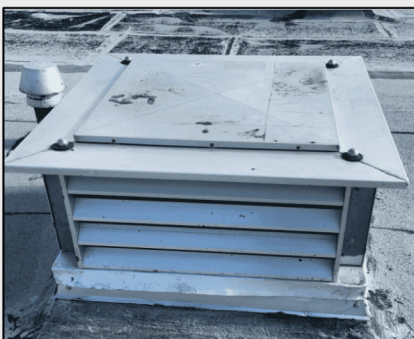
#### 1. Replace Outdated HVAC Equipment

A number of the buildings HVAC assets were originally installed in the 1990s, or earlier. This includes many of the building's rooftop exhaust fans. Note, this measure includes several rooftop air handling units. While these assets were refurbished approximately 10 years ago; they will likely require some refurbishment or replacement during this period depending on component conditions.

- RTU-1 (FCAID-500067)
- RTU-2 (FCAID-500068)
- RTU-3 (FCAID-500069)
- RTU-4 (FCAID-500070)
- RTU-1 (FCAID-500066)
- Rooftop Unit (FCAID-500113)
- Condensing Unit M41 (FCAID-500084)
- (10) Exhaust Fans (FCAIDs vary)
- Unit Heater (FCAID-500114)
- CW Air Separator (FCAID-500074)
- HW Air Separator (FCAID-500075)
- Glycol Feeder (FCAID-500108)

**Priority Level:** 2  
**Estimated Cost:** \$809,060  
**Remaining Life:** 2-7 years

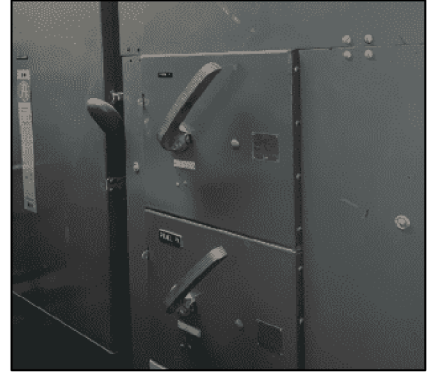
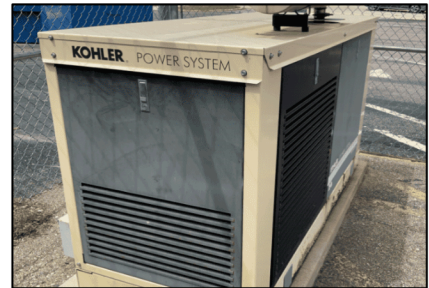
## 2. Replaced Outdated Electrical Assets

- Main Switchboard, Section 1 (FCAID-500155)
- Main Switchboard, Section 2 (FCAID-500156)
- Backup Generator (FCAID-500124)
- Panel A (FCAID-500135)
- Panel B (FCAID-500136)
- Panel K (FCAID-500142)
- Panel L (FCAID-500143)
- Panel LAP (FCAID-500144)
- Panel MM (FCAID-500148)
- ATS (FCAID-500123)

**Priority Level:** 2  
**Estimated Cost:** \$141,570  
**Remaining Life:** 3-5 years

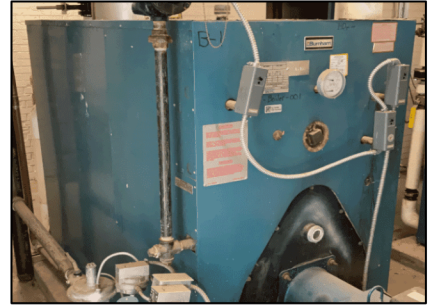
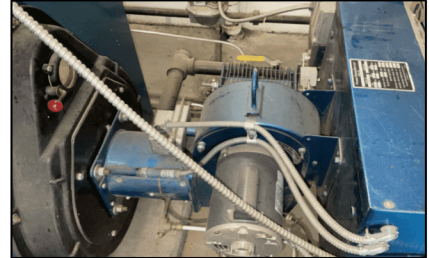
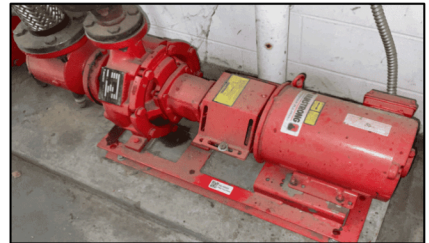
## 4. Prepare for Boiler Replacement

While the building's two boilers are currently functional, they are now nearly 30 years old. Typical boilers are manufactured with a lifespan of around 35 years. Plan for replacement or substantial refurbishment of the heating water system within the next 5-7 years to ensure that is operating efficiently, and as designed.

- Boiler B-1 (FCAID-500102)
- Boiler B-2 (FCAID-500103)
- P-1 (FCAID-500110)
- P-2 (FCAID-500111)
- ET-1 (FCAID-500099)
- ET-2 (FCAID-500101)

**Priority Level:** 3  
**Estimated Cost:** \$164,040  
**Remaining Life:** 5-7 years

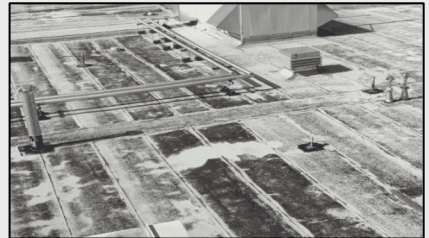
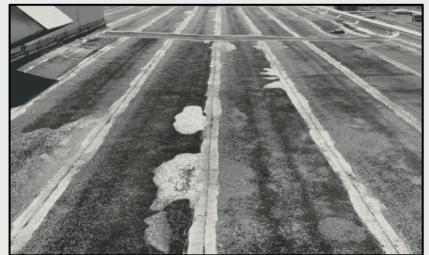
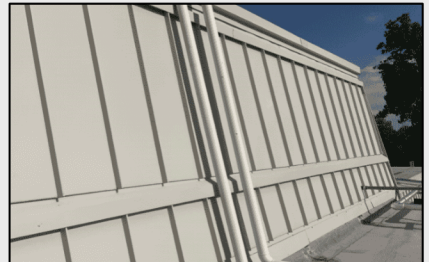
## 5. Replace or Refurbish the Roofing

The building's roofing was noted [REDACTED] with areas of cracking and degradation of the reflective top coating. Plan for substantial repairs of the roofing surface within the next 7 years to ensure a water tight envelope.

- Roofing, Rolled Asphalt (FCAID-500022)
- Roofing, Metal Standing Seam (FCAID-500024)
- Roofing, Metal Flashing (FCAID-500021)
- Roofing, Rolled Asphalt, Gym Addition (FCAID-500023)

**Priority Level:** 3  
**Estimated Cost:** \$634,220  
**Remaining Life:** 4-7 years
