POUDRE SCHOOL
DISTRICT
PUTNAM
ELEMENTARY
SCHOOL

FACILITY CONDITION ASSESSMENT

FORT COLLINS, CO

OCTOBER 2023

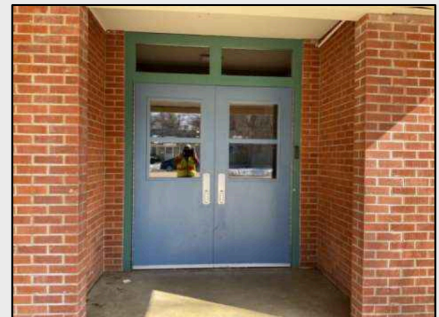
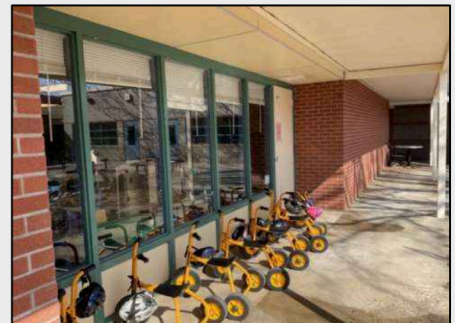
Replace Exterior Doors & Windows

[Redacted text]

FCAID-470001, FCAID-470007, FCAID-470008, FCAID-470011

Priority Level: 2
Estimated Cost: \$474,890
Remaining Life: 1 year

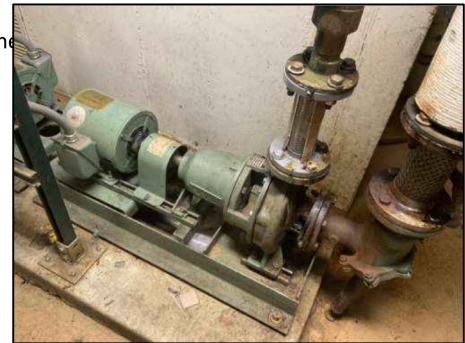
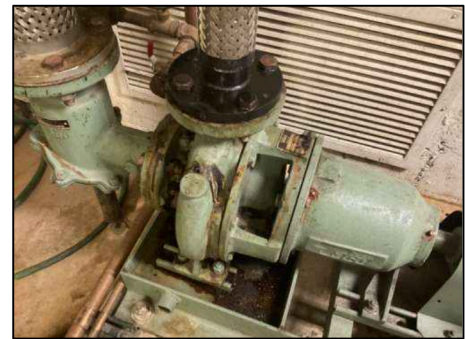
Replace HWP-1 & HWP-2

Hwp-1 and HWP-2 were installed in 1998 and are now 5 years past expected life. They are both [REDACTED] expected to require replacement within two years.

FCAID-470101, FCAID-470102

Priority Level: 2
Estimated Cost: \$23,800
Remaining Life: 2 years

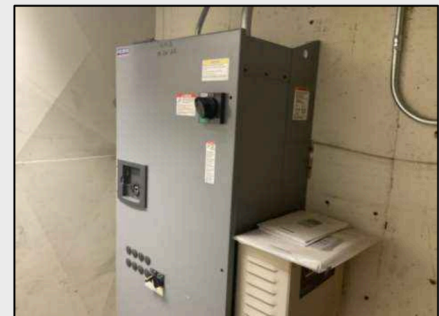
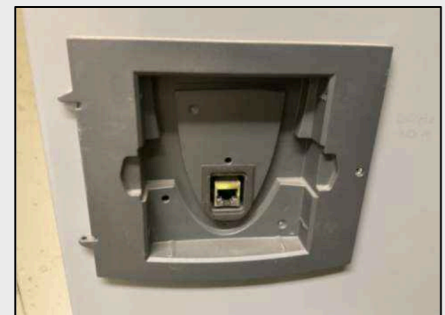
Repair/Replace VFD-AHU-1-Supply

Though VFD-AHU-1-Supply (10 Hp) was newly installed in 2022, the control module was observed to have been removed at the time of inspection. Recommend repair or replacement of this VFD as soon as possible.

FCAID-470147

Priority Level: 2
Estimated Cost: \$5,840
Remaining Life: 1 year
