POUDRE SCHOOL  
DISTRICT  
TRAUT ELEMENTARY  
SCHOOL

FACILITY CONDITION ASSESSMENT

FORT COLLINS, CO

OCTOBER 2023

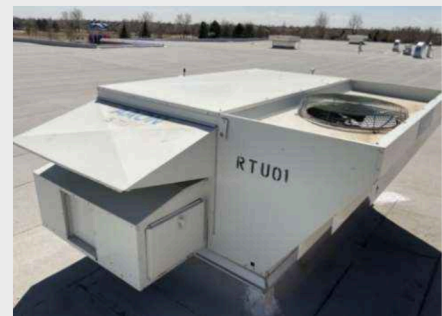
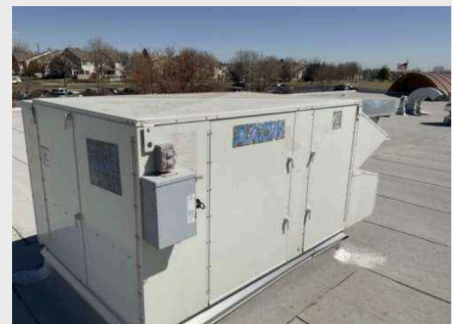
#### Replace RTU-1 & RTU-2

RTU-1 and RTU-2 are original 1998-built units [REDACTED]. They are 10 years past expected useful life, and have approximately 2 years of remaining life.

<b>Priority Level:</b>	2
<b>Estimated Cost:</b>	\$87,320
<b>Remaining Life:</b>	2 Years

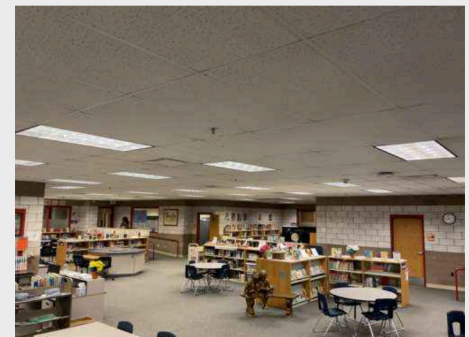
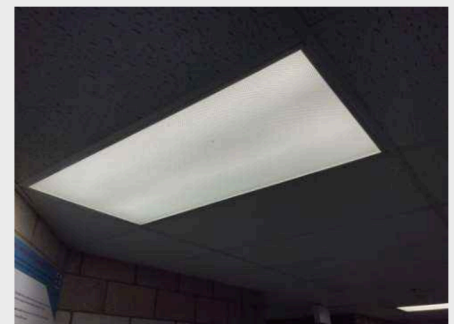
## Replace Interior Fluorescent Lighting

Recommend replacement of the 1998-built fluorescent lighting fixtures with LED lighting fixtures within 2 years. Fluorescent fixtures are 5 years past expected life.

**Priority Level:** 2  
**Estimated Cost:** \$778,840  
**Remaining Life:** 2 Years

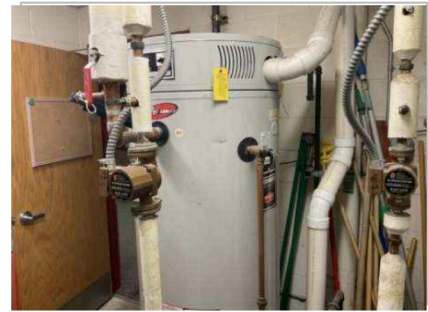
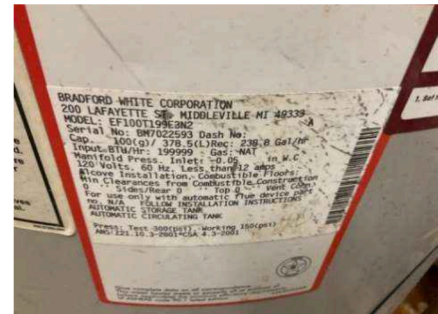
## Replace GWH-1

GWH-1, built in 2005, is 8 years past expected life. Recommend replacement within the next three years.

Priority Level: 2  
Estimated Cost: \$10,610  
Remaining Life: 3 Years

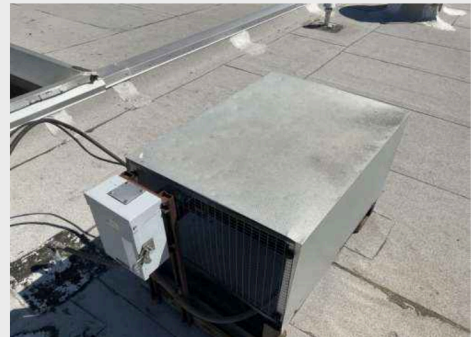
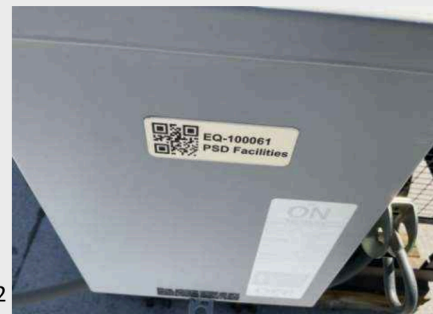
## Replace CU-1-Walk-In Cooler

The single condensing unit associated with the cooler is 10 years past expected life. Replace CU-1-Walk-In Cooler within two years.

Priority Level: 2  
Estimated Cost: \$10,050  
Remaining Life: 2 Years
