POUDRE SCHOOL  
DISTRICT  
OLANDER  
ELEMENTARY  
SCHOOL

**FACILITY CONDITION ASSESSMENT**

FORT COLLINS, CO

OCTOBER 2023

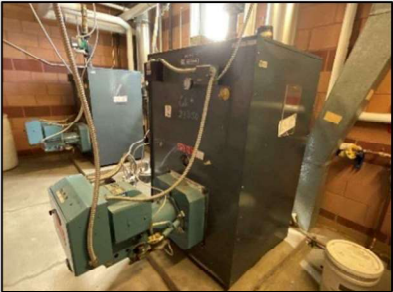
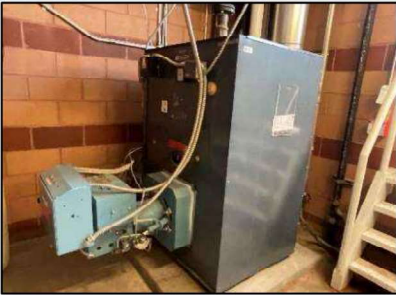
#### Replace Boilers

The two existing boilers serving the school's hot water system, are nearing the end of their life expectancy and are anticipated to need replacement within the next five years.

FCAID-400038, FCAID-400039

**Priority Level:** 2  
**Estimated Cost:** \$157,260  
**Remaining Life:** 5 Years

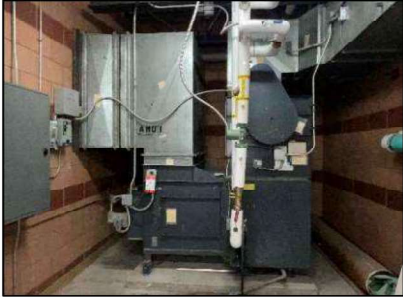
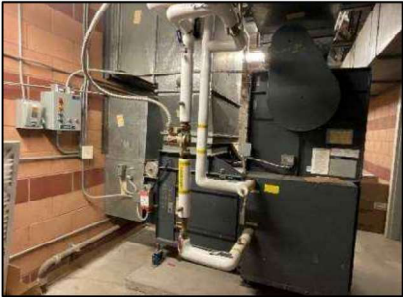
## Replace AHU-1 and AHU-2

The two air handling units in the mechanical mezzanine space, AHU-1 and AHU-2, have surpassed their industry life expectancy by nearly ten years, [REDACTED]. These two units should be replaced within the next three years.

FCAID-400035, FCAID-400036

**Priority Level:** 1  
**Estimated Cost:** \$195,530  
**Remaining Life:** 3 Years

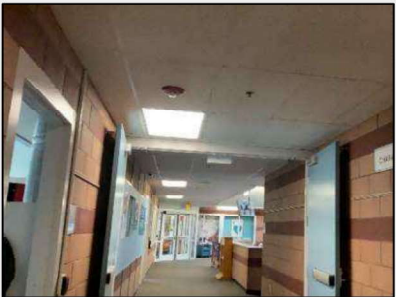
## Replace Interior Fluorescent Lighting

The interior lighting fixtures are nearing the end of their recommended lifespan. Consider upgrading the interior and exterior lighting to light emitting diode (LED) fixtures to reduce energy costs and maintenance needs.

FCAID-400131

**Priority Level:** 2  
**Estimated Cost:** \$786,690  
**Remaining Life:** 4 Years

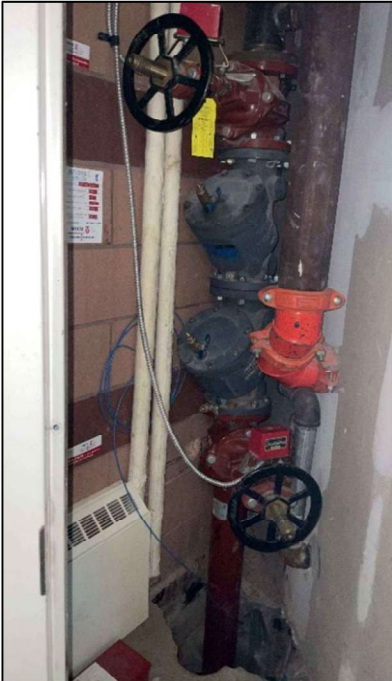
## Replace Wet Sprinkler System

The wet sprinkler system was estimated to have been installed during original construction, this would indicate that it is nearing the end of its industry life expectancy and should be replaced within the next six years.

FCAID-400128

**Priority Level:** 2  
**Estimated Cost:** \$891,000  
**Remaining Life:** 6 Years

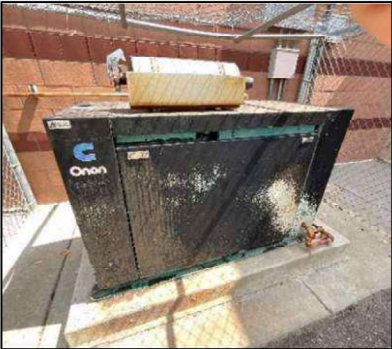
## Replace Emergency Generator

The emergency generator [REDACTED] has surpassed its industry life expectancy. This asset should be replaced within the next four years.

FCAID-400151

**Priority Level:** 2  
**Estimated Cost:** \$28,150  
**Remaining Life:** 4 Years
