POUDRE SCHOOL DISTRICT ROCKY MOUNTAIN HIGH SCHOOL

FACILITY CONDITION ASSESSMENT

FORT COLLINS, CO

OCTOBER 2023

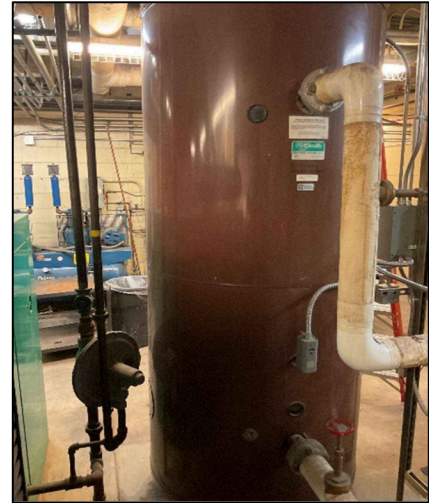
Replace Kitchen Storage Tank

The kitchen storage tank serving the DHWS has surpassed its industry life expectancy, [REDACTED]. It is recommended that this unit be replaced within the next year.

Priority Level: 2
Estimated Cost: \$16,090
Remaining Life: 1 year

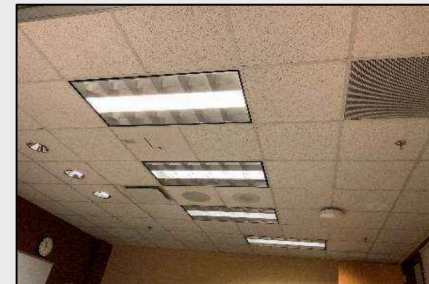
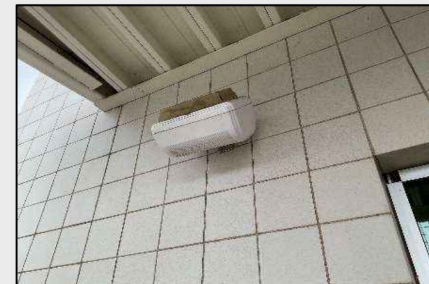
Replace Fluorescent and Incandescent Lighting Fixtures

Interior lighting mostly consists of fluorescent lighting. Exterior lighting is made up, in part, of incandescent and fluorescent fixtures [REDACTED]. Consider upgrading the interior and exterior lighting to LED fixtures to reduce energy costs and maintenance needs.

Priority Level: 2
Estimated Cost: \$3,296,760
Remaining Life: 4 years
