POUDRE SCHOOL
DISTRICT

POLARIS
EXPEDITIONARY
LEARNING K-12

FACILITY CONDITION ASSESSMENT

MARCH 2023

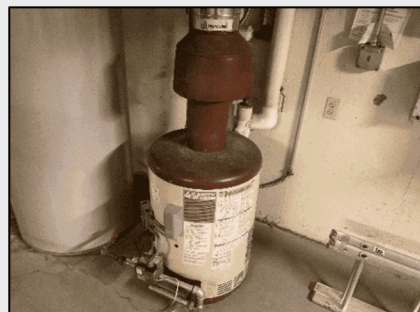
1. Replace GWH-1

Serving the DHW needs of the building, GWH-1 was built in 1996 and is now 17 years past expected useful life. The water heater is [REDACTED] recommended that it be replaced within the year.

Priority Level:	2
Estimated Cost:	\$10,610
Remaining Life:	≤ 1 Year

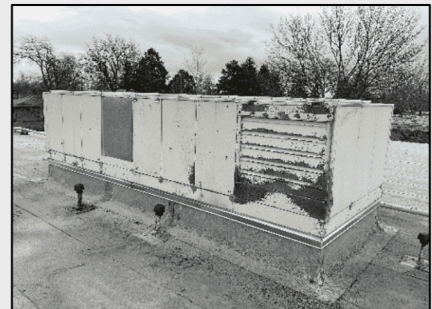
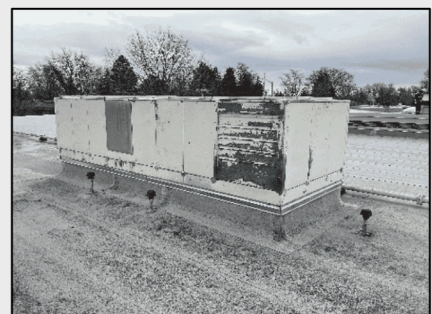
3. Replace MZU-1 and MZU-2

These multi-zone air units were built in 1994 and are now 14 years past expected useful life. The MZUs were [REDACTED] recommended that they be replaced within the year prior to failure.

Priority Level: 2
Estimated Cost: \$145,820
Remaining Life: ≤ 1 Year

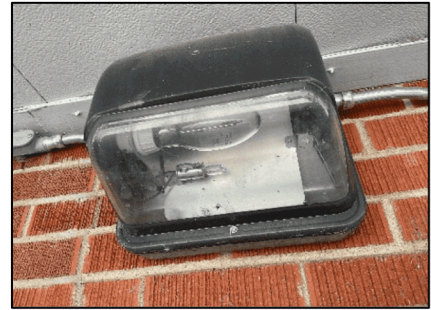
4. Replace Exterior Wall Pack Lighting

The 25 exterior incandescent wall pack light fixtures were installed in 1996. These assets are [REDACTED] and seven years past expected life. The plastic covers are opaque and discolored. Recommend replacement with LED fixtures within two years.

Priority Level: 2
Estimated Cost: \$15,160
Remaining Life: ≤ 2 Years

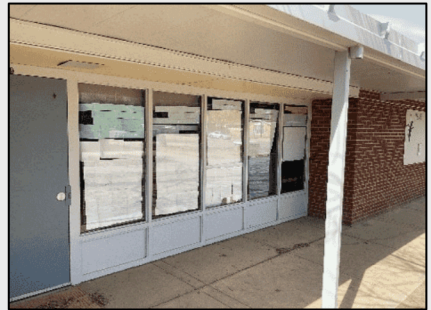
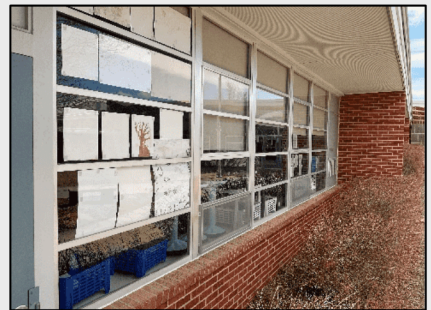
5. Replace Exterior Windows

The original 1958 exterior wood windows are 35 years past expected life. Steel casement windows dating to 1956 and 1966 are now 27-37 years past life. Recommend that these original windows be replaced within 1-2 years.

Priority Level: 3
Estimated Cost: \$226,760
Remaining Life: ≤ 1-2 Years
