POUDRE SCHOOL
DISTRICT
BAUDER
ELEMENTARY
SCHOOL

FACILITY CONDITION ASSESSMENT

FORT COLLINS, CO

OCTOBER 2023

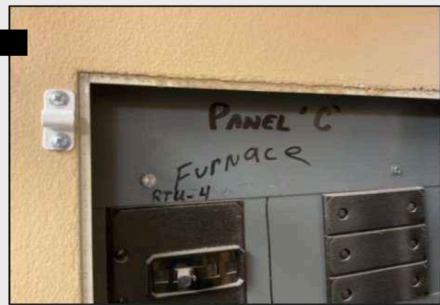
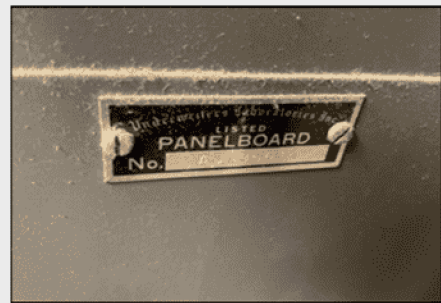
Replace Panel C

Panel C dates to 1968 and is now 15 years past expected life. [REDACTED]

Priority Level:	1
Estimated Cost:	\$4,740
Remaining Life:	1 Year

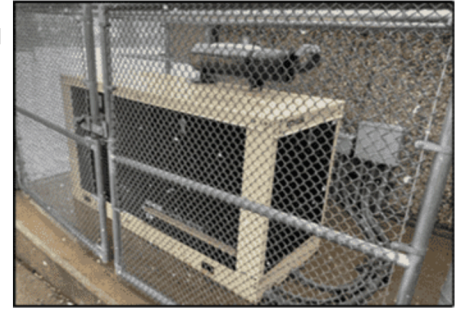
Replace Emergency Back-Up Generator

The Generator was built in 1992 and is 11 years past expected life. Per PSD, the Total Generator Run Hours = 339.5 . Recommend replacement within three years.

Priority Level: 2
Estimated Cost: \$22,400
Remaining Life: 3 Years

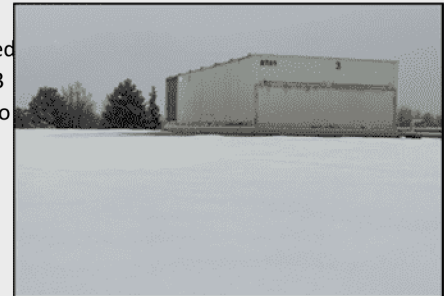
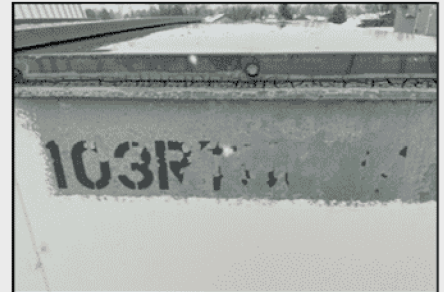
Replace 1992 Rooftop Units

RTU-3 and RTU-103 (RTU-9) are both 1992-built Temptrol units 6 years past expected life. RTU-3 is [REDACTED], requiring replacement within the year. RTU-103 (RTU-9 in the BAS) [REDACTED] a recommended replacement within two years.

Priority Level: 2
Estimated Cost: \$213,300
Remaining Life: 1-2 Years

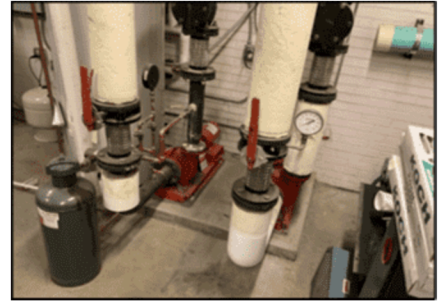
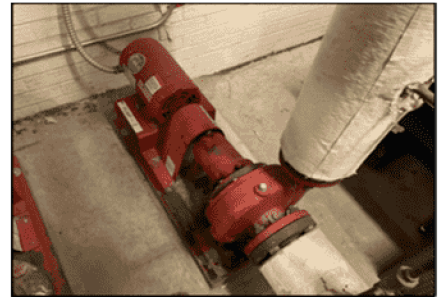
Replace P-1 & P-2

P-1 and P-2 serve as the HWS circulation pumps. They date to 1992 and are both 11 years past expected life. [REDACTED]. Recommend replacement within two years, or in 4 years when Boilers 1 and 2 are expected to require replacement.

Priority Level: 2
Estimated Cost: \$16,600
Remaining Life: 2-4 Years

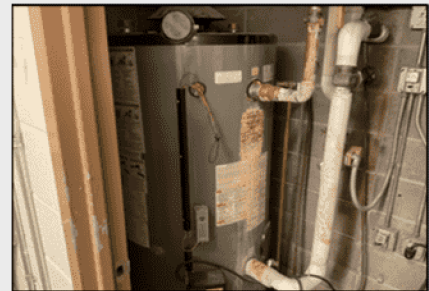
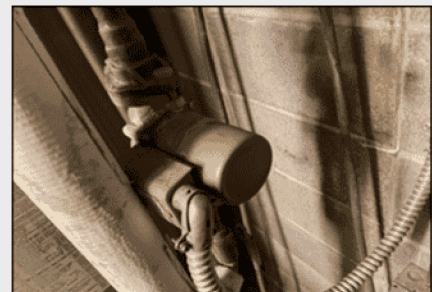
Replace GWH-1 & DHWCP-1

GWH-1 and associated circulation pump DHWCP-1 were both observed to have leakage and corrosion. Both are recommended to be replaced within two years

Priority Level: 2
Estimated Cost: \$15,240
Remaining Life: 2 Years
