POUDRE SCHOOL DISTRICT TIMNATH ELEMENTARY SCHOOL

FACILITY CONDITION ASSESSMENT

TIMNATH, CO
OCTOBER 2023

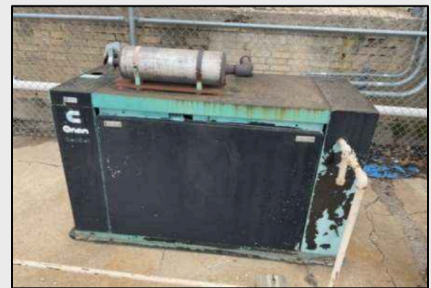
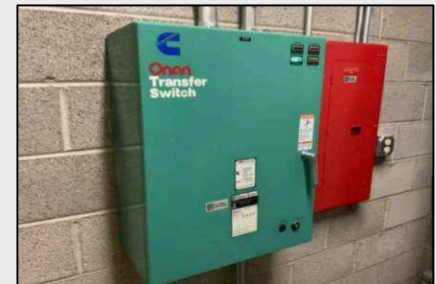
Replace Back-Up Generator & ATS-1

The back-up generator serving this building dates to 1992 [REDACTED] Total Run Hours = 753.0 . The associated ATS-1 dates to 1997 and should be replaced at the time that the generator is replaced.

Priority Level:	1
Estimated Cost:	\$55,610
Remaining Life:	1-3 Years

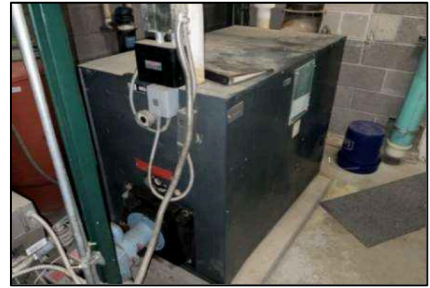
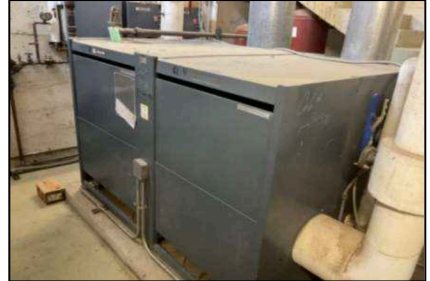
Replace Boiler-1-North, Boiler-2-North, Boiler-3-South

All three boilers are at expected life and are expected to require replacement within two years. [REDACTED]

Priority Level: 2
Estimated Cost: \$231,380
Remaining Life: 2 Years

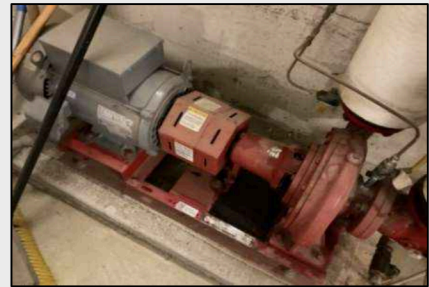
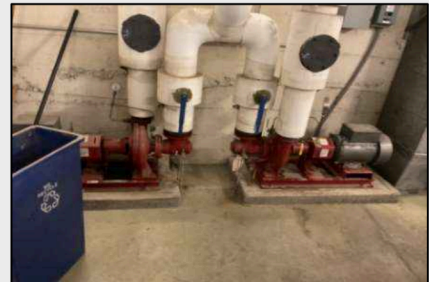
Replace P-1 & P-2

Heating Water Pumps P-1 and P-2 date to 1992, are 11 years past expected life, and are expected to require replacement within two years.

Priority Level: 2
Estimated Cost: \$23,800
Remaining Life: 2 Years

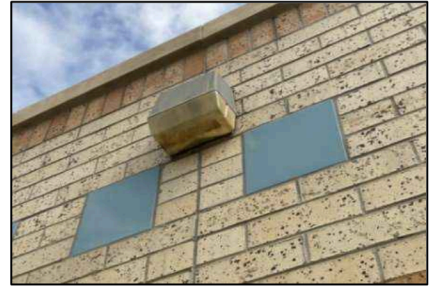
Replace (17) Incandescent Exterior Wall Packs

Priority Level: 2
Estimated Cost: \$10,310
Remaining Life: 1-3 Years

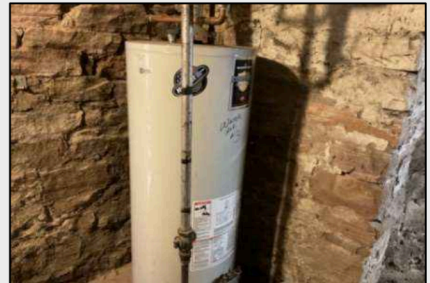
Replace GWH-3 (Annex)

GWH-3 (located in Annex Building) dates to 2005 [REDACTED] requiring replacement in two years.

Priority Level: 2
Estimated Cost: \$9,650
Remaining Life: 2 Years
