# POUDRE SCHOOL DISTRICT ZACH ELEMENTARY SCHOOL

## FACILITY CONDITION ASSESSMENT

FORT COLLINS, CO

OCTOBER 2023

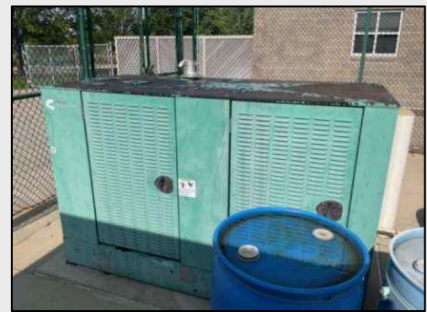
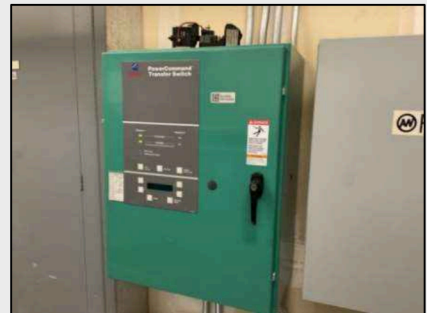
#### Replace Back-Up Generator & ATS-1

The back-up generator is original, needing replacement within in 2 years. 2002-built ATS-1 has approximately 4 years of remaining life, but is recommended to be replaced in tandem with the generator. The generator has total run hours of 370.2

<b>Priority Level:</b>	1
<b>Estimated Cost:</b>	\$51,270
<b>Remaining Life:</b>	1-2 Years

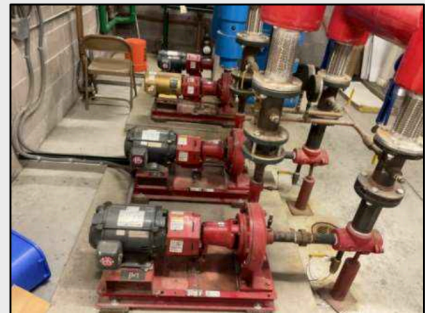
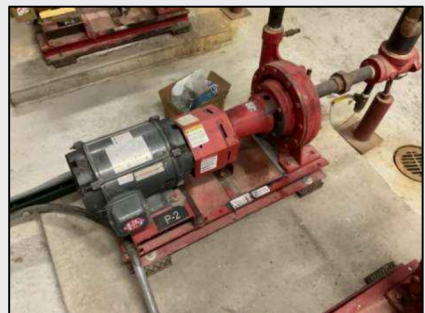
## Replace P-1, P-2, P-3, & P-4

P-1 and P-2 (3 Hp, serving Heating Water System) and P-3 and P-4 (5 Hp, serving Chilled Water System) are all 2002-built pumps. Though the motors of all 4 have recently been replaced, the pumps themselves are past expected life [REDACTED]

**Priority Level:** 2  
**Estimated Cost:** \$47,244  
**Remaining Life:** 2 Years

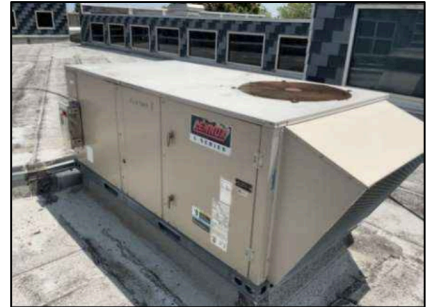
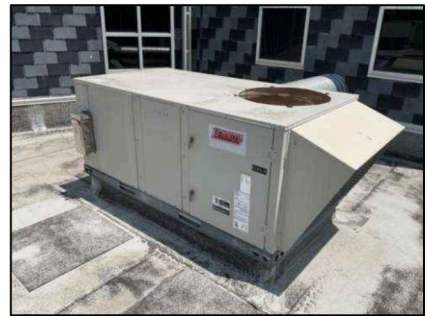
## Replace CLRTU-1 & CLRTU-2

Serving the Computer Laboratory Rooms, these 2002-built RTUs [REDACTED] [REDACTED] are both 6 years past expected life. Recommend replacement within two years. HCFC-22 refrigerant.

**Priority Level:** 2  
**Estimated Cost:** \$62,320  
**Remaining Life:** 2 Years

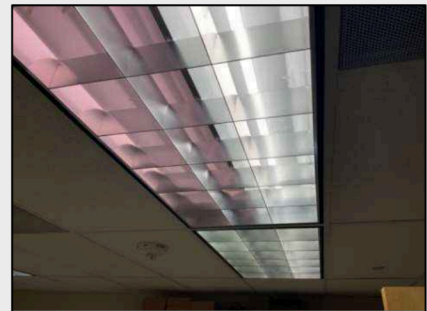
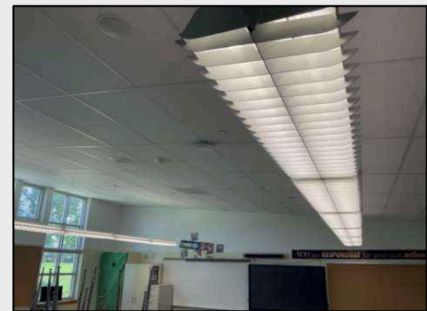
## Replace Interior Fluorescent Lighting

Recommend replacement of the original remaining fluorescent lighting fixtures with LED lighting fixtures in approximately 2 years. SF = 59,938

**Priority Level:** 2  
**Estimated Cost:** \$917,650  
**Remaining Life:** 2 Years
