POUDRE SCHOOL
DISTRICT
LAUREL
ELEMENTARY
SCHOOL

FACILITY CONDITION ASSESSMENT

FORT COLLINS, CO

OCTOBER 2023

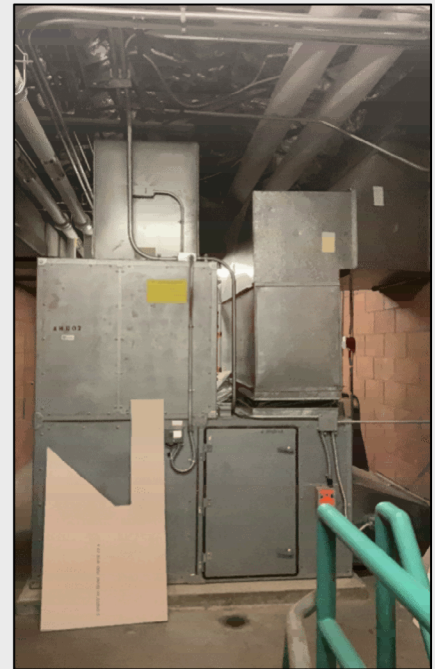
Replace Air Handling Units

The two air handling units in the mezzanine have surpassed their industry life expectancies [REDACTED]. These three units should be replaced within the next five years.

FCAID-310034, FCAID-310035

Priority Level:	2
Estimated Cost:	\$193,040
Remaining Life:	5 years

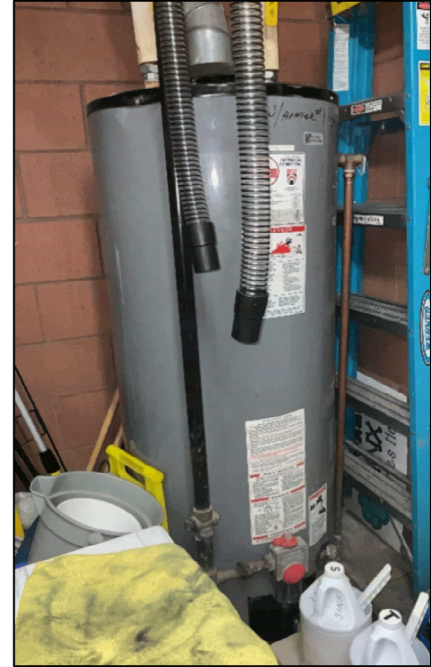
Replace Water Heaters

The two water heaters installed during original construction in 1993 have surpassed their life expectancy, are in poor condition, and are anticipated to need replacement within the next two years.

FCAID-310030, FCAID-310032

Priority Level: 2
Estimated Cost: \$19,300
Remaining Life: 2 years

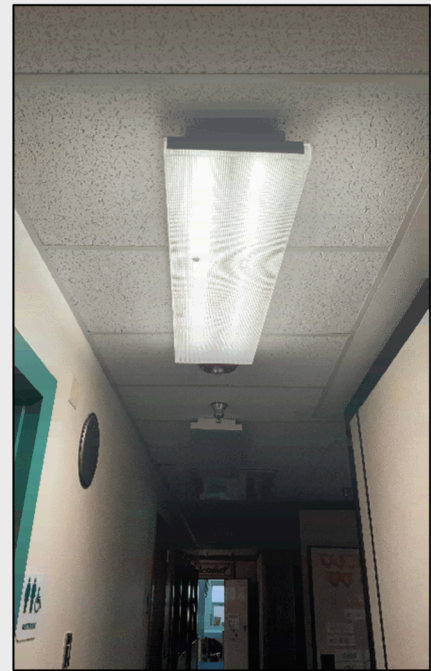
Replace Fluorescent Lighting Fixtures

Interior lighting consists of fluorescent fixtures. Consider upgrading the interior lighting to light emitting diode (LED) fixtures to reduce energy costs and maintenance needs.

FCAID-310136

Priority Level: 2
Estimated Cost: \$786,690
Remaining Life: 4 years

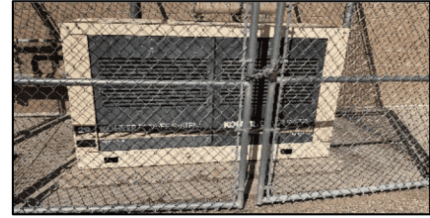
Replace Emergency Generator

The emergency generator is [REDACTED] [REDACTED] anticipated to need replacement within the next four years.

FCAID-310135

Priority Level: 2
Estimated Cost: \$28,150
Remaining Life: 4 years
