POUDRE SCHOOL
DISTRICT
KRUSE ELEMENTARY
SCHOOL

FACILITY CONDITION ASSESSMENT

FORT COLLINS, CO

OCTOBER 2023

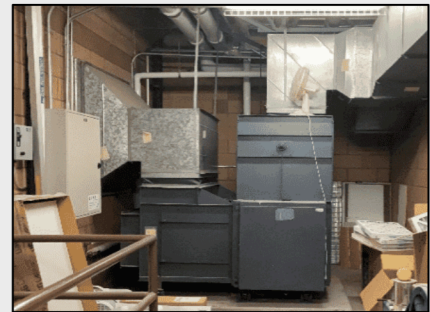
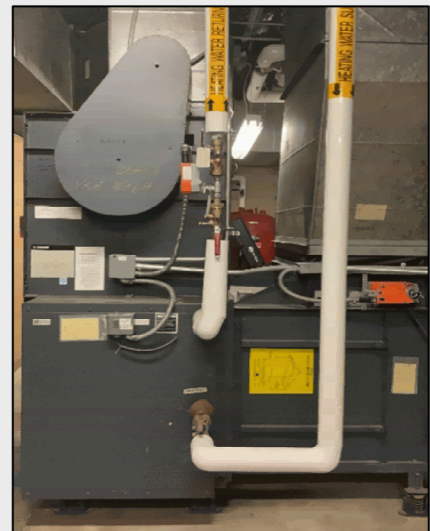
Replace Air Handling Units

The two air handling units in the mezzanine have surpassed their industry life expectancies and a [REDACTED] should be replaced within the next three years.

FCAID-290035, FCAID-290036

Priority Level: 2
Estimated Cost: \$193,040
Remaining Life: 3 years

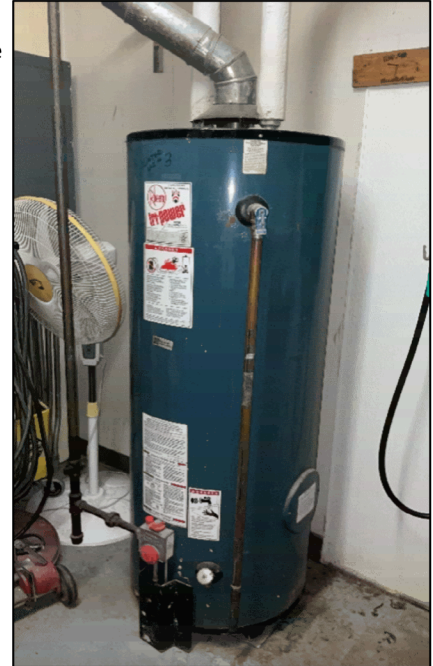
Replace Water Heaters

The three water heaters installed in 1992 and 2002 have surpassed their life expectancy, [REDACTED] and are anticipated to need replacement within the next two years.

FCAID-290031, FCAID-290033, FCAID-290034

Priority Level: 2
Estimated Cost: \$28,950
Remaining Life: 2 years

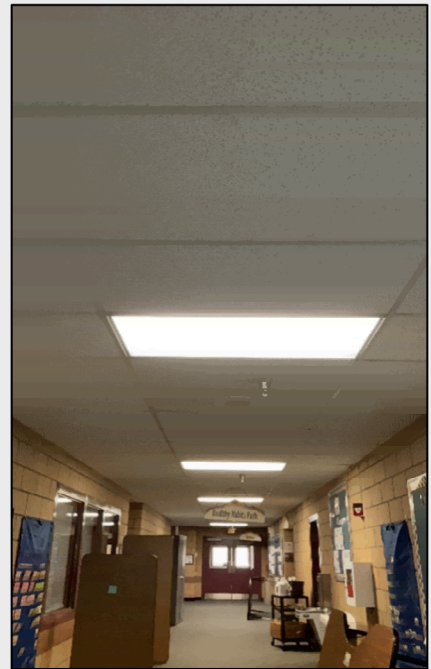
Replace Fluorescent Lighting Fixtures

Interior lighting consists of fluorescent fixtures. Consider upgrading the interior lighting to light emitting diode (LED) fixtures to reduce energy costs and maintenance needs.

FCAID-290130

Priority Level: 2
Estimated Cost: \$786,690
Remaining Life: 4 years

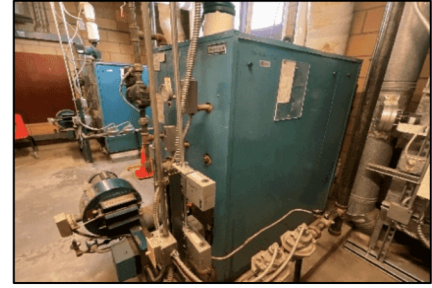
Replace Boilers

The two boilers serving the school's hot water system are nearing the end of their life expectancy. They are [REDACTED] anticipated to need replacement within the next five years.

FCAID-290087, FCAID-290088

Priority Level: 2
Estimated Cost: \$182,030
Remaining Life: 5 years
