POUDRE SCHOOL  
DISTRICT  
JOHNSON  
ELEMENTARY  
SCHOOL

**FACILITY CONDITION ASSESSMENT**

FORT COLLINS, CO

OCTOBER 2023

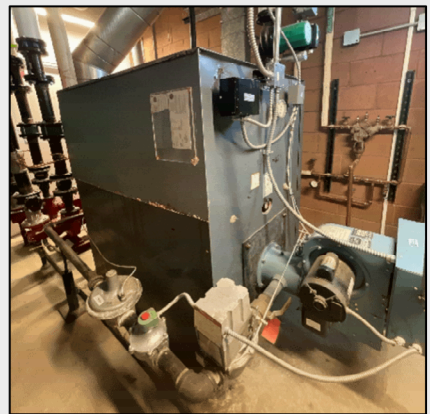
##### Replace Boilers

The two boilers serving the school's hot water system have reached the end of their life expectancy. They are [REDACTED] anticipated to need replacement within the next five years.

FCAID-270078, FCAID-270079

Priority Level:	2
Estimated Cost:	\$182,030
Remaining Life:	5

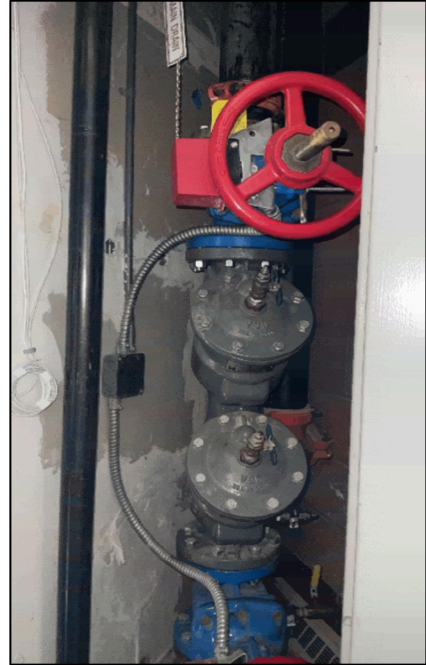
## Replace Wet Sprinkler System

The school has a wet sprinkler system [REDACTED]  
[REDACTED]  
[REDACTED]  
[REDACTED]

FCAID-270132

**Priority Level:** 1  
**Estimated Cost:** \$977,910  
**Remaining Life:** 4

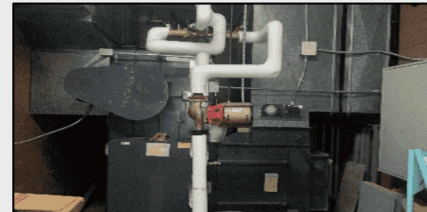
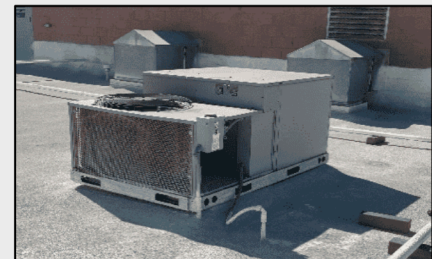
## Replace Air Handling and Rooftop Units

The two air handling units in the mezzanine, along with RTU-3, have surpassed their industry life expectancies and [REDACTED] should be replaced within the next 2-3 years.

FCAID-270037, FCAID-270038, FCAID-270126

**Priority Level:** 2  
**Estimated Cost:** \$228,420  
**Remaining Life:** 2-3 years

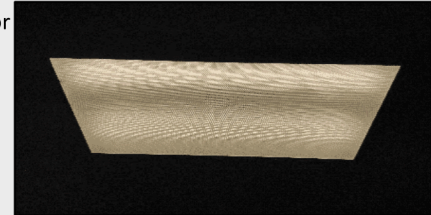
## Replace Fluorescent Lighting Fixtures

Interior lighting consists of mostly fluorescent fixtures. Consider upgrading the interior and exterior lighting to light emitting diode (LED) fixtures to reduce energy costs and maintenance needs.

FCAID-270138

**Priority Level:** 2  
**Estimated Cost:** \$817,490  
**Remaining Life:** 4 years
