POUDRE SCHOOL DISTRICT RICE ELEMENTARY SCHOOL

FACILITY CONDITION ASSESSMENT

WELLINGTON, CO

OCTOBER 2023

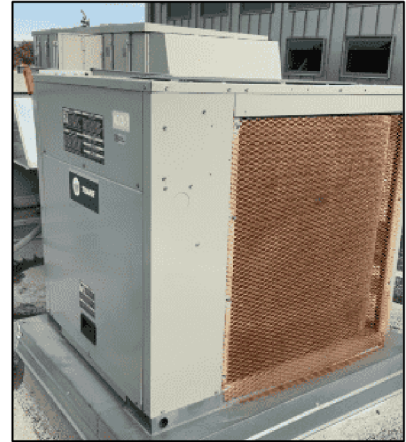
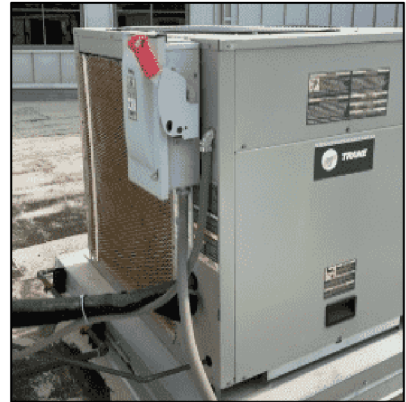
Replace ACCU-1

ACCU-1 is past expected life [REDACTED]. Recommend replacement within two years.

Priority Level: 2
Estimated Cost: \$25,130
Remaining Life: 2 Years

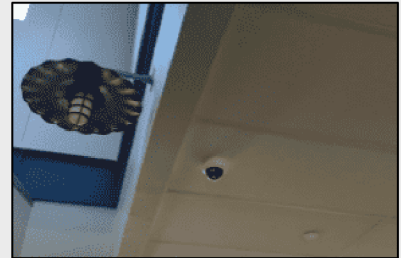
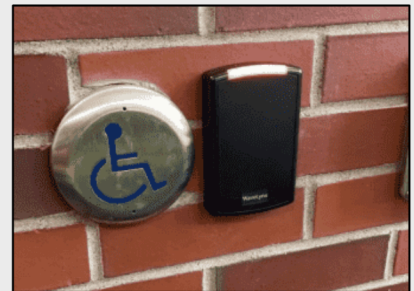
Update Security System

[REDACTED]
Recommend replacement within the next year. [REDACTED]

Priority Level: 1
Estimated Cost: \$250,880
Remaining Life: 1 year

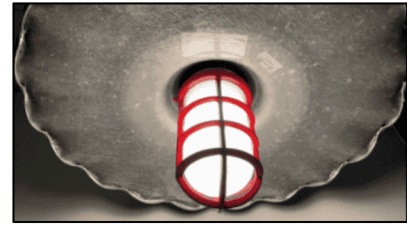
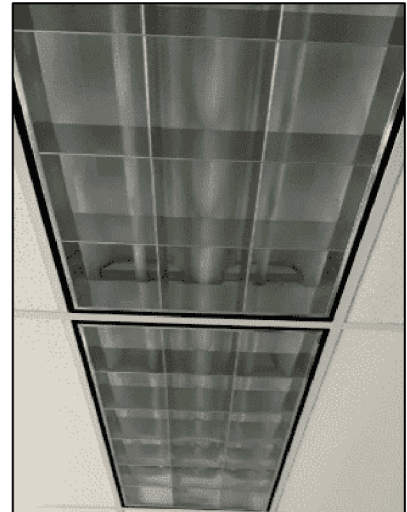
Replace Interior Incandescent & Fluorescent Lighting

Recommend replacement of the remaining fluorescent and incandescent lighting fixtures with LED lighting fixtures within 4 years.

Priority Level: 2
Estimated Cost: \$950,170
Remaining Life: 4 Years

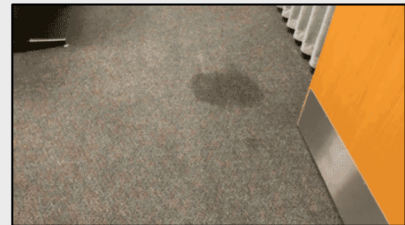
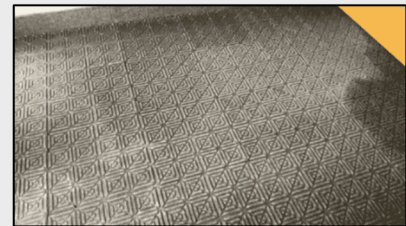
Replace Carpeting

Carpeting is 6 years past expected life. ██████████ Replace within 2 years.

Priority Level: 2
Estimated Cost: \$773,070
Remaining Life: 2 Years
