POUDRE SCHOOL  
DISTRICT  
LIVERMORE  
ELEMENTARY  
SCHOOL

FACILITY CONDITION ASSESSMENT

LIVERMORE, CO

OCTOBER 2023

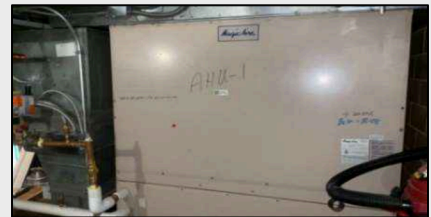
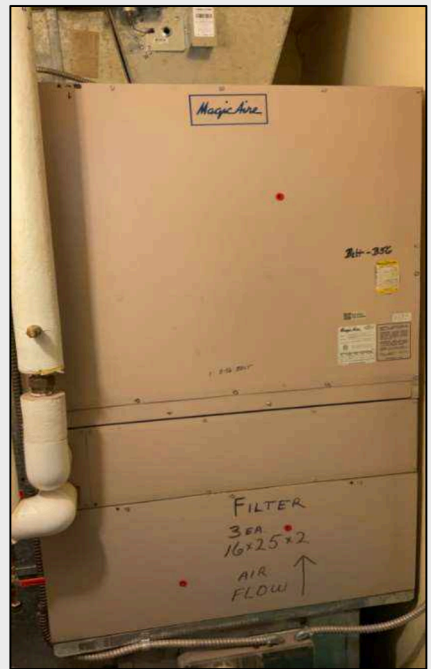
### Replace AHU-1, AHU-2, & AHU-3

AHU-1, AHU-2, and AHU-3 are 1993-built AHUs in poor condition. These are Magic Aire Fan Coil Units labeled as AHUs. These include pneumatic valves and dampers and are 5 years past expected life. [REDACTED]

Priority Level: 2  
Estimated Cost: \$117,320  
Remaining Life: 2 years

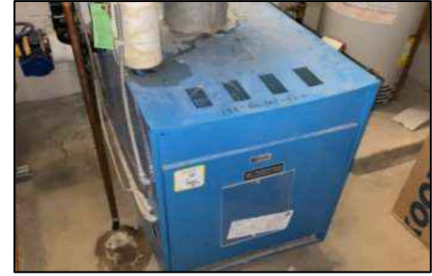
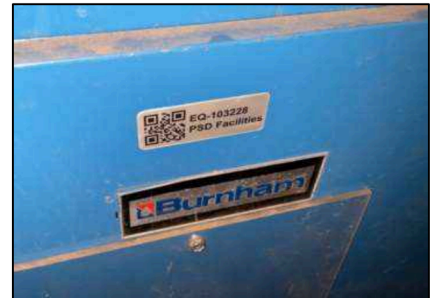
## Replace Boiler-2

Though Boiler-1 was replaced in 2015, Boiler-2 dates to 1983 and is 5 years past expected life. [REDACTED]

**Priority Level:** 2  
**Estimated Cost:** \$37,000  
**Remaining Life:** 2 years

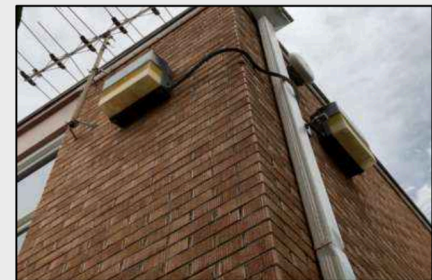
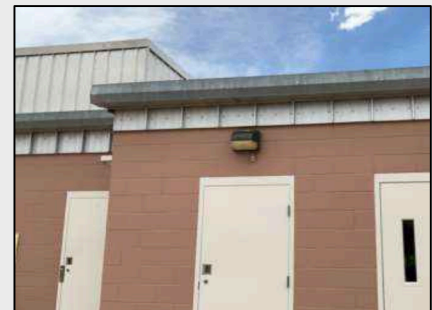
## Replace (6) Incandescent Exterior Wall Packs

Six exterior incandescent wall packs date to 1993 and are 10 years past expected life. Recommend upgrading to LED fixtures within two years.

**Priority Level:** 2  
**Estimated Cost:** \$3,640  
**Remaining Life:** 1 year

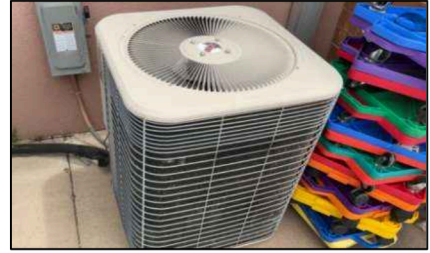
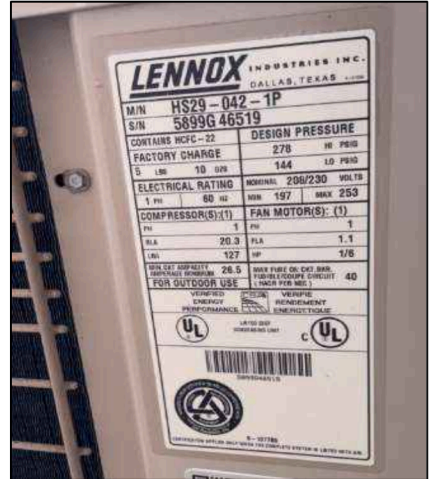
## Replace CU-1

CU-1, serving the Computer Room Furnace, is 8 years past expected life. [REDACTED]

**Priority Level:** 2  
**Estimated Cost:** \$20,110  
**Remaining Life:** 2 years

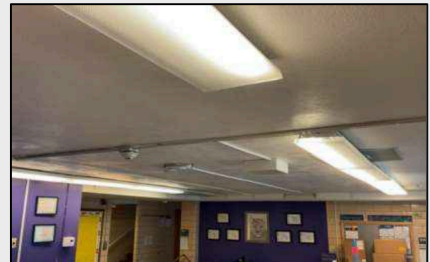
## Replace Interior Fluorescent Lighting

All interior fluorescent lighting was updated in 2000. Recommend updating to LED fixtures within two years.

**Priority Level:** 2  
**Estimated Cost:** \$171,620  
**Remaining Life:** 2 years
