LESHER IB WORLD MIDDLE SCHOOL

POUDRE SCHOOL
DISTRICT

FACILITY CONDITION ASSESSMENT

MARCH 2023

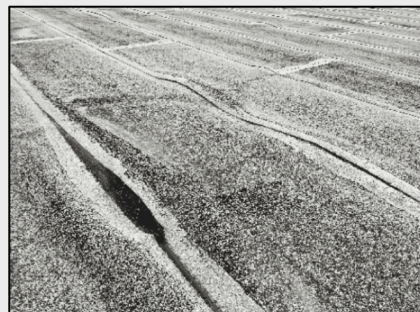
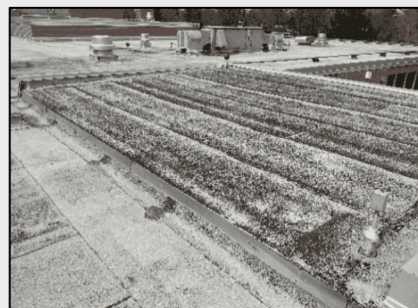
1. Replace Rolled Asphalt Roofing

The 1993 and 1972 [REDACTED] Roofing material is bubbled up and has visible cracks. Recommend replacement of these sections within the year.

FCAID-320020, FCAID-320021

Priority Level:	2
Estimated Cost:	\$42,630
Remaining Life:	≤ 1 Year

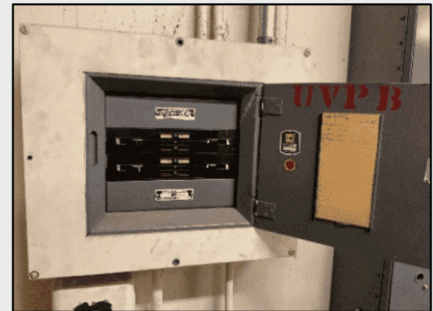
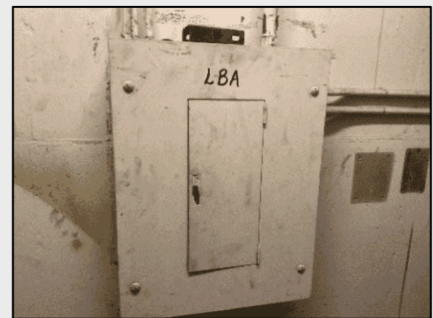
3. Replace Older Electrical Panelboards

Nine of the electrical panelboards date to 1980 and [REDACTED] Recommend replacement within the year.

FCAID-320210, FCAID-320214, FCAID-320214, FCAID-320215, FCAID-320216, FCAID-320217, FCAID-320218, FCAID-320219, FCAID-320225

Priority Level:	2
Estimated Cost:	\$28,620
Remaining Life:	≤ 1 Year

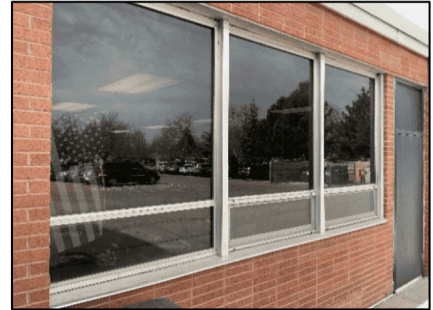
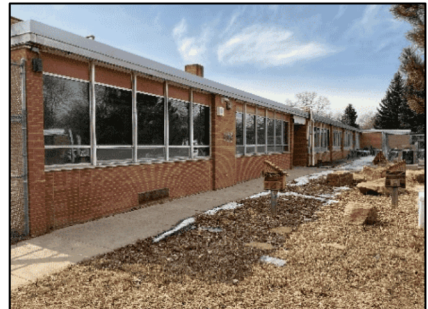
4. Replace Exterior Windows

FCAID-320012, FCAID-320013, FCAID-320014, FCAID-320015

Priority Level: 3
Estimated Cost: \$367,840
Remaining Life: ≤ 2 Years

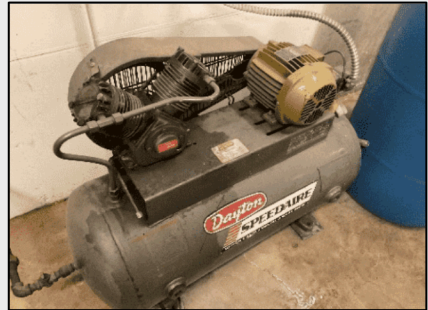
5. Replace Air Compressor

The 1978-built air compressor [REDACTED]. Recommend that the air compressor be replaced within two years.

FCAID-320042

Priority Level: 3
Estimated Cost: \$4,520
Remaining Life: ≤ 2 Years
