POUDRE SCHOOL DISTRICT

BOLTZ MIDDLE SCHOOL

FACILITY CONDITION ASSESSMENT

OCTOBER 2023

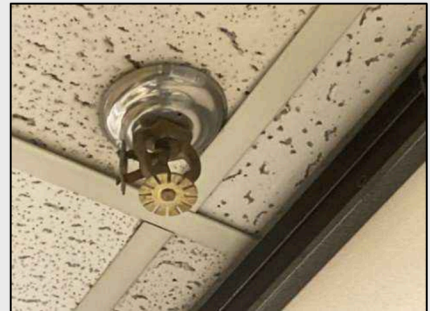
Wet Fire Sprinkler System

The fire alarm system was updated in 2012, [REDACTED]
[REDACTED]
[REDACTED]
[REDACTED]

Priority Level:	1
Estimated Cost:	\$938,870
Remaining Life:	1 Year

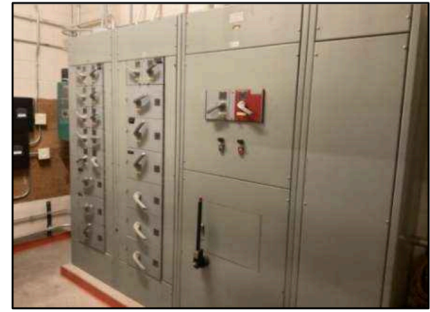
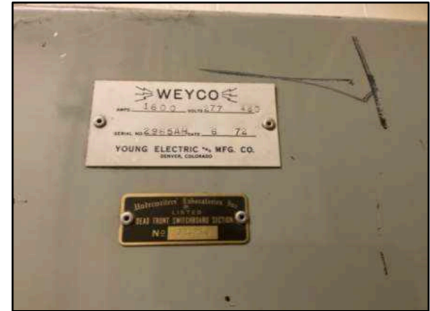
1972 Electrical Asset Replacement

[REDACTED]

Priority Level: 1
Estimated Cost: \$165,740
Remaining Life: 1-2 Years

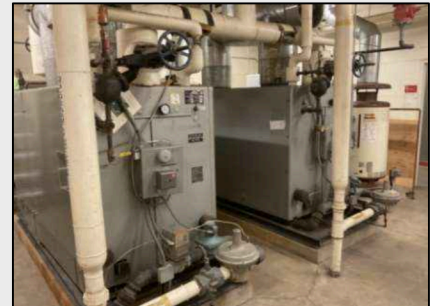
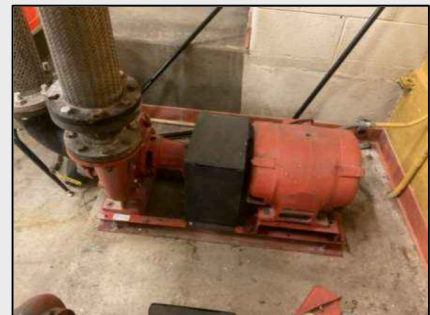
Boiler & HWP Replacement

The heating water system features two 1972-built gas-fired boilers that are 16 past expected life, and two 1972-built circulation pumps that are 31 years past expected life. [REDACTED]

Priority Level: 1
Estimated Cost: \$419,020
Remaining Life: 1 Year

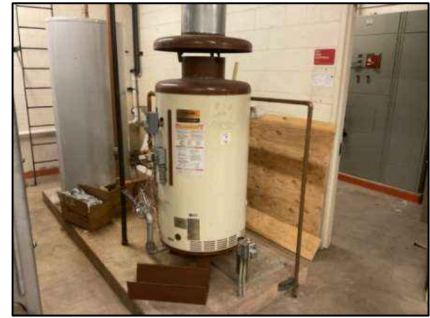
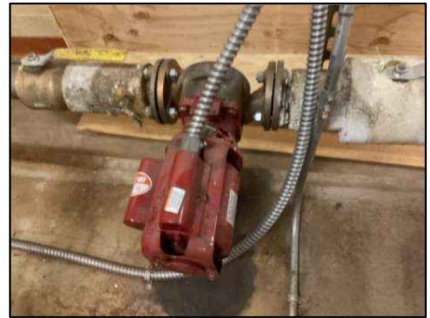
Replace GWH-1, P-3, P-4

Plumbing assets include a single 1992-built gas-fired water heater [REDACTED] and two circulation pumps [REDACTED] P-3 is four years past expected life and P-4 is 11 years past expected life. [REDACTED]

Priority Level: 2
Estimated Cost: \$87,680
Remaining Life: 1-2 Years

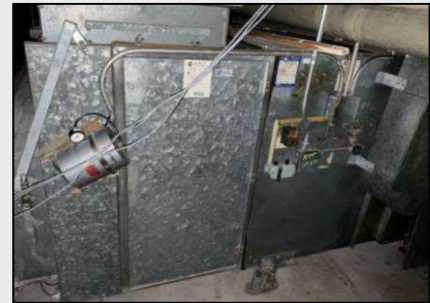
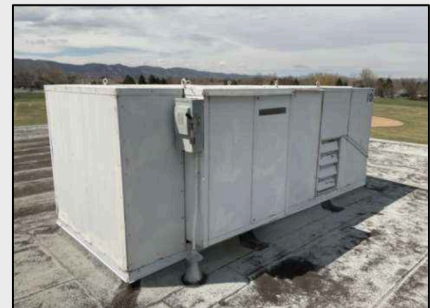
AHU & RTU Replacement

The (5) 1972-built AHUs and (7) of the 1972-built RTUs were observed to be [REDACTED] requiring replacement within the year. AHUs are 26 year past due and RTUs are 16 years past expected life. Measure includes AHUs 16,5,6,7,8 and RTUs 2,10,11,12,13,14,15.

Priority Level: 2
Estimated Cost: \$1,274,930
Remaining Life: 1 Year
