CACHE LA POUUDRE
MIDDLE SCHOOL

FACILITY CONDITION ASSESSMENT

FORT COLLINS, CO

OCTOBER 2023

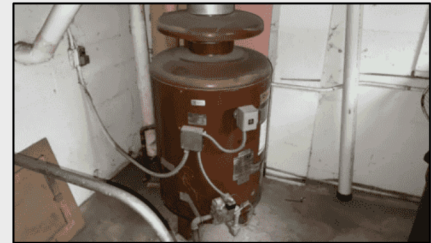
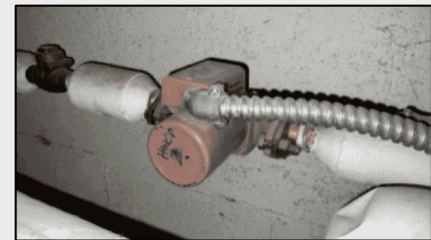
Replace GWH-1, DHWCP-1, DHWCP-2

GWH-1 was built in 1980 and is 33 years past expected life. DHWCP-1 and DHWCP-2 date to 1994 and are 9 years past expected life. Recommend replacement of these assets within 1-2 years as they are the sole source of domestic hot water in the main school.

Priority Level:	2
Estimated Cost:	\$27,520
Remaining Life:	1-2 years

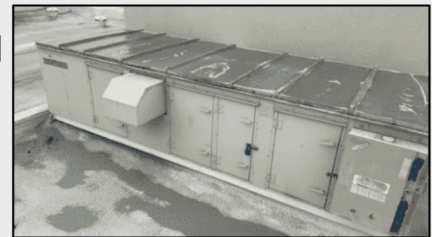
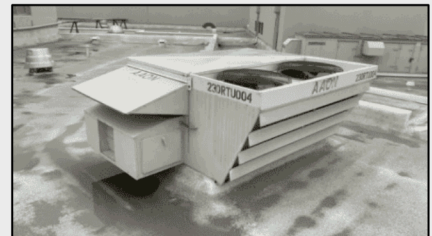
Replace RTU-2, RTU-3, & RTU-4

RTU-2, RTU-3, & RTU-4 are the remaining units that were installed in 1997. These are well past expected life. [REDACTED]

Priority Level: 2
Estimated Cost: \$400,200
Remaining Life: 2 Years

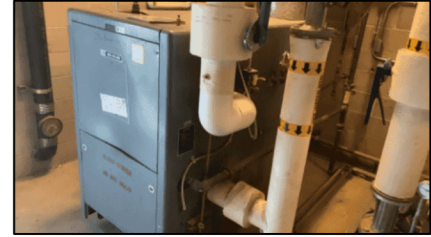
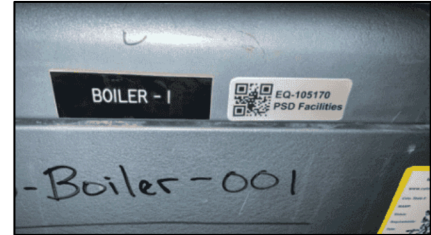
Replace Boiler-1

Boiler-2 was replaced in 1997 and has 9 years of remaining life. Boiler-1 dates to 1984, is 4 years past expected life, [REDACTED]
Recommend replacement of Boiler-1 prior to 2024-2025 heating season.

Priority Level: 2
Estimated Cost: \$63,070
Remaining Life: 2 years

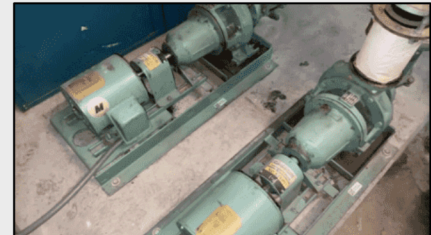
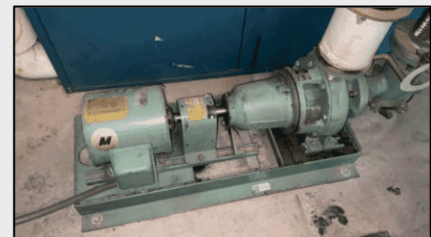
Replace P-1 & P-2

Heating Water System P-1 and P-2 (both 5 Hp) are 6 years past due and will require replacement within the year. [REDACTED]

Priority Level: 2
Estimated Cost: \$23,800
Remaining Life: 2 years
