HARRIS ELEMENTARY SCHOOL

FACILITY CONDITION ASSESSMENT

FORT COLLINS, CO

MARCH 2023

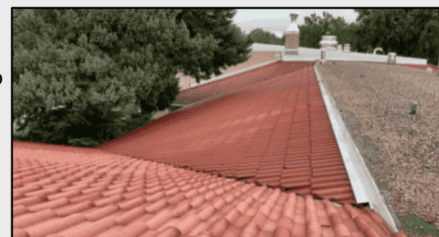
Red Clay Tile Roofing

3,500 SF of red clay tile roofing was replaced in 2002. This type of roofing has a 50 year expected useful life per BOMA. This roof has approximately 29 years of remaining life at present. No deficiencies or repairs were noted during the FCA inspection. This is not a "Top Deficiency Issue", it is listed at #1 due to PSD's request to determine whether additional assessment is required. In McKinstry's opinion an additional assessment of this roof is not required at present.

Priority Level:	3
Estimated Cost:	\$62,900
Remaining Life:	29

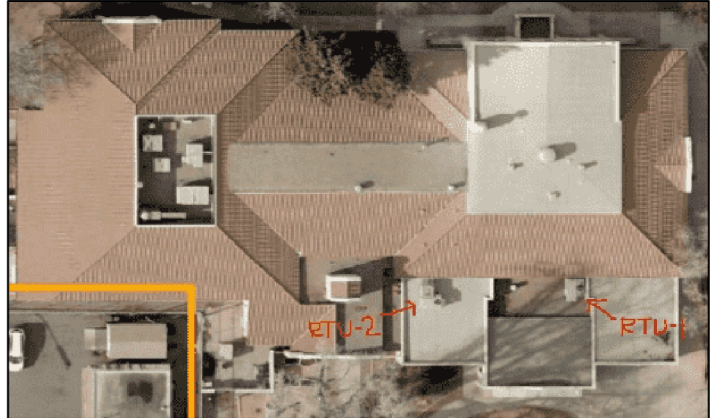
Replace RTU-1 and RTU-2

RTUs 1 (served Administration Area) & 2 (serves Admin & Classrooms) are seven years and ten years past expected useful life respectively. They are both expected to require replacement within the next two years. No access to this section of roof due to red clay tile roof safety issues.

Priority Level: 2
Estimated Cost: \$63,900
Remaining Life: 2

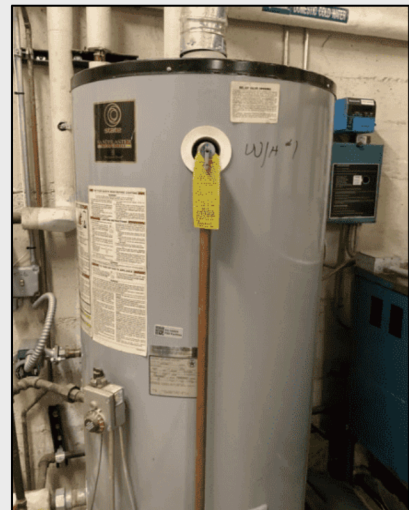
Replace WH-1

WH-1 (75 Gal, 75MBH) was installed in 2001, and is therefore 12 years past expected useful life. Anticipate replacement within the next two years.

Priority Level: 2
Estimated Cost: \$10,610
Remaining Life: 2

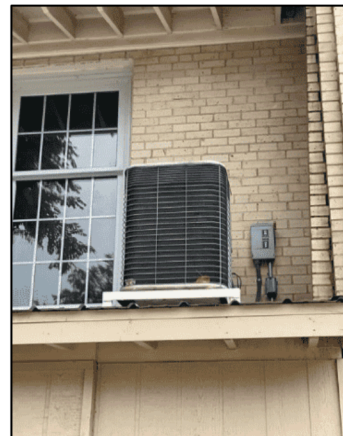
Replace CU-1 and CU-Walk-in Cooler/Freezer

CU-1 (serving F-1), and CU-Walk-in Cooler/Freezer (serving the kitchen walk-in cooler and freezer) were installed 2001-2002. Therefore, they are 7 and 6 years past expected useful life at present. Expect to replace these condensing units within two years.

Priority Level:	2
Estimated Cost:	\$45,240
Remaining Life:	2

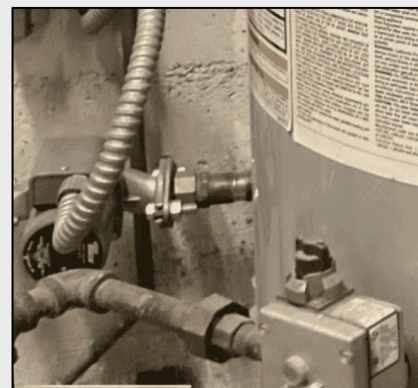
Replace CP-1

CP-1 (1/25 Hp) serves WH-1 and is two years past expected useful life. Recommend replacing this pump at the same time that WH-1 is replaced in two years.

Priority Level:	2
Estimated Cost:	\$4,631
Remaining Life:	2
