POUDRE SCHOOL  
DISTRICT  
WERNER  
ELEMENTARY  
SCHOOL

FACILITY CONDITION ASSESSMENT

FORT COLLINS, CO

OCTOBER 2023

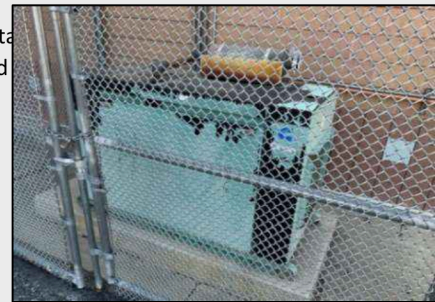
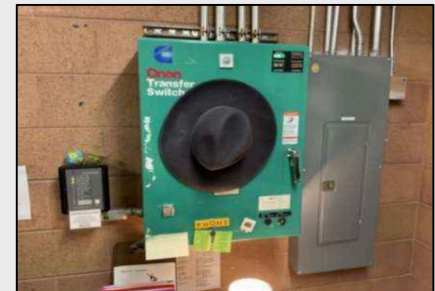
##### Replace Back-Up Generator & ATS-1

The back-up generator is original [REDACTED] Total Generator Run Hours = 435.1, which is high. The associated ATS-1 is also original and should be replaced when the generator is replaced.

<b>Priority Level:</b>	2
<b>Estimated Cost:</b>	\$66,170
<b>Remaining Life:</b>	1-5 Years

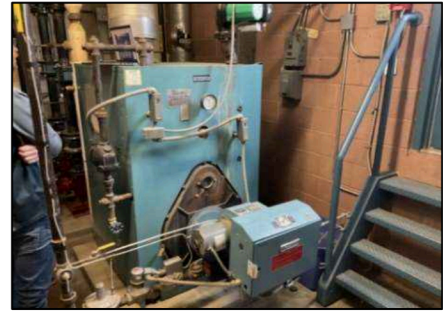
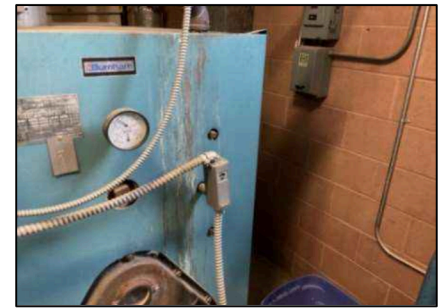
## Replace Boiler-1

Though Boiler-2 was replaced in 2008, Boiler-1 (1,116 MBH) is original [REDACTED] Recommend replacement within 2 years.

**Priority Level:** 2  
**Estimated Cost:** \$78,630  
**Remaining Life:** 2 Years

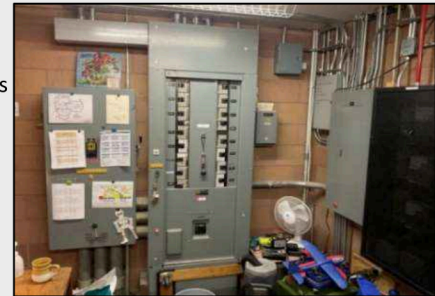
## Replace Panel MDP

Panel MDP (1997-built, 600A) was not replaced in 2012 along with other electrical assets. [REDACTED] Panel MDP is expected to require replacement in 4 years at end of life.

**Priority Level:** 2  
**Estimated Cost:** \$12,370  
**Remaining Life:** 4 Years

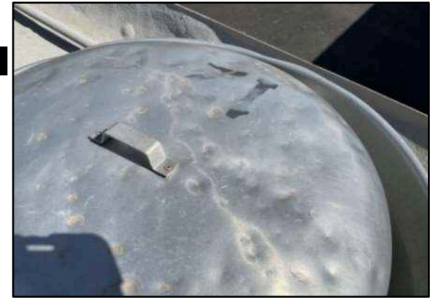
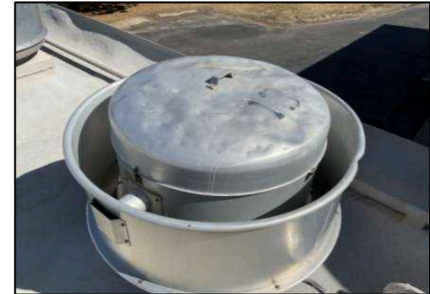
## Replace EF-12 & EF-13

EF-12 and EF-13 (both 2 Hp and serving the Kitchen) are original [REDACTED]. These fans are 16 years past expected life.

**Priority Level:** 2  
**Estimated Cost:** \$19,180  
**Remaining Life:** 2 Years

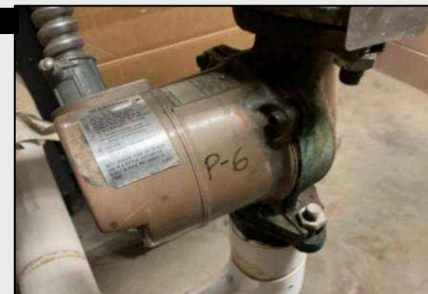
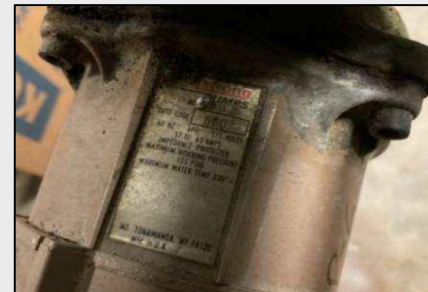
## Replace P-6

P-6 (1/25 Hp and serving the AHU-2 HW Coil) is 17 years past expected life [REDACTED].

**Priority Level:** 2  
**Estimated Cost:** \$4,630  
**Remaining Life:** 1 Year
