POUDRE SCHOOL DISTRICT O'DEA ELEMENTARY SCHOOL

FACILITY CONDITION ASSESSMENT

FORT COLLINS, CO

OCTOBER 2023

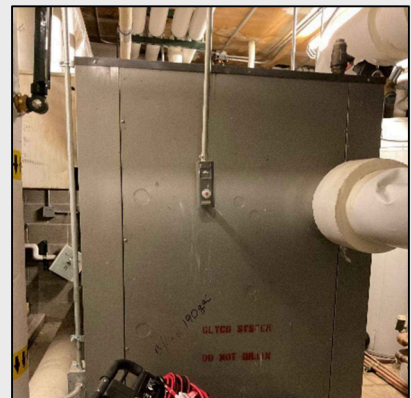
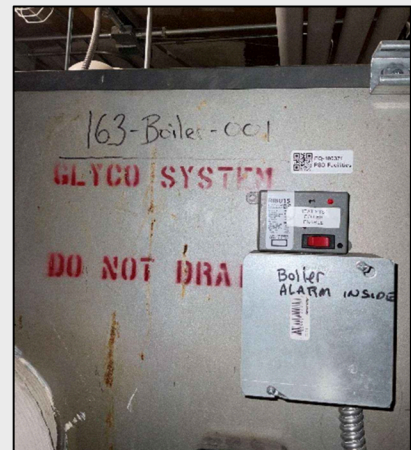
FCAID-390135

1. Replace Boiler 1

The boiler B-1 was installed in 1962, [REDACTED] and has surpassed the end of its life expectancy by nearly 30 years. This boiler should be replaced within the next year.

| Priority Level: | 2 |
| Estimated Cost: | \$127,750 |

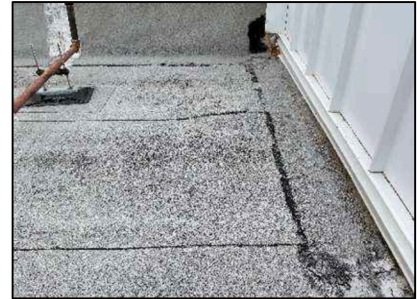
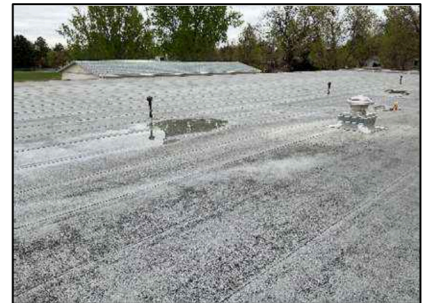
FCAID-390031

2. Replace Rolled Asphalt Roofing

The rolled asphalt roofing is in poor condition and is nearing the end of its industry life expectancy. A roof leak was observed in the Annex section during inspection along with lots of standing water, bubbled up areas, and visible cracks. Rolled asphalt roofing should be replaced within the next two years.

Priority Level: 2
Estimated Cost: \$292,390
Remaining Life: 2 Years

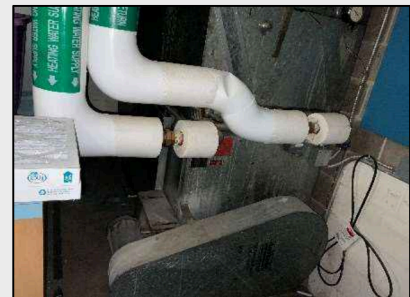
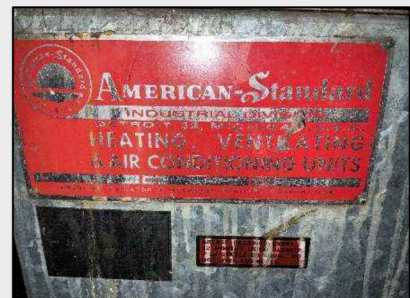
FCAID-390078

3. Replace AHU-1

AHU-1 was installed in 1966, [REDACTED] and has surpassed the end of its life expectancy by over 30 years. This air handling unit should be replaced within the next year.

Priority Level: 2
Estimated Cost: \$117,170
Remaining Life: 1 Year

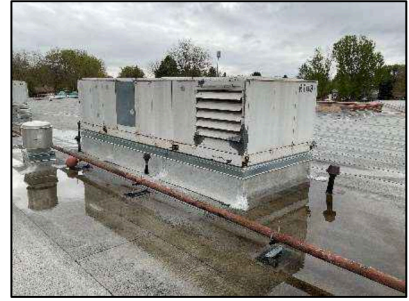
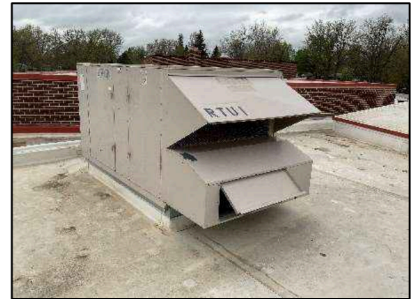
FCAID-390151, FCAID-390152, FCAID-390153

4. Replace Rooftop Units

The rooftop units RTU-1, RTU-3, and RTU-4, were installed in 1994, [REDACTED] and have surpassed the end of their life expectancies. These rooftop units should be replaced within the next year.

Priority Level: 2
Estimated Cost: \$351,510
Remaining Life: 1 Year

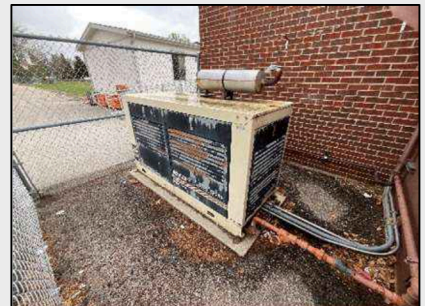
FCAID-390080

5. Replace Emergency Generator

The emergency is estimated to have been installed in 1994, [REDACTED] It should be replaced within the next year.
