POUDRE SCHOOL
DISTRICT
EYESTONE
ELEMENTARY
SCHOOL NORTH

FACILITY CONDITION ASSESSMENT

WELLINGTON, CO

OCTOBER 2023

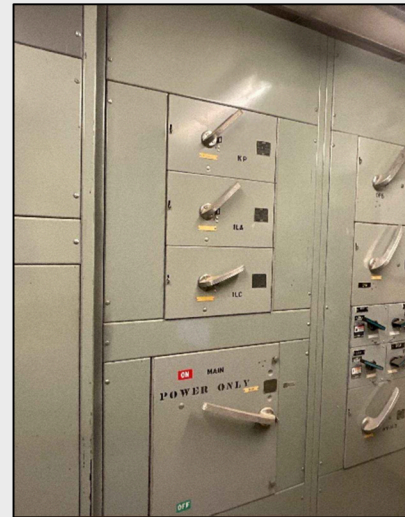
Replace Switchboard

[REDACTED]

FCAID-180160, FCAID-180161, FCAID-180162

Priority Level: 2
Estimated Cost: \$126,570
Remaining Life: 2 years

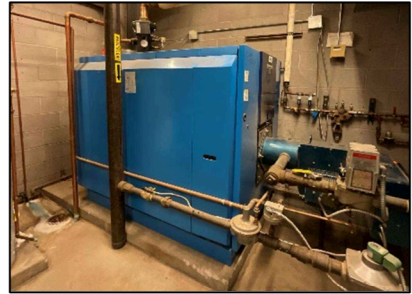
Replace Boilers

The boilers were installed in 1988 and 1990 [REDACTED]. They are anticipated to need replacement within the next two years.

FCAID-180091, FCAID-180092

Priority Level: 2
Estimated Cost: \$197,380
Remaining Life: 2 years

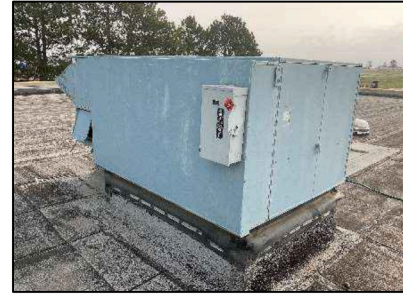
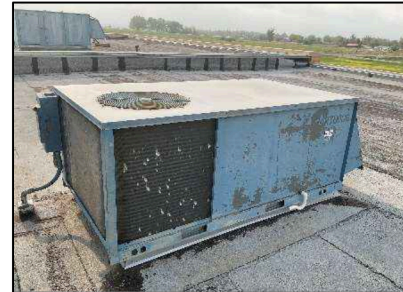
Replace Rooftop Units

Five of the rooftop units, serving various classrooms and the gym, are in poor condition. These units have surpassed their industry life expectancies. It is recommended that these five units be replaced within the next two years.

FCAID-180100, FCAID-180101, FCAID-180102, FCAID-180103, FCAID-180104

Priority Level: 2
Estimated Cost: \$258,640
Remaining Life: 2 years

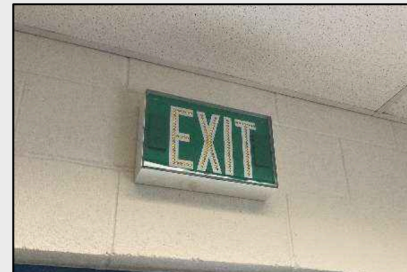
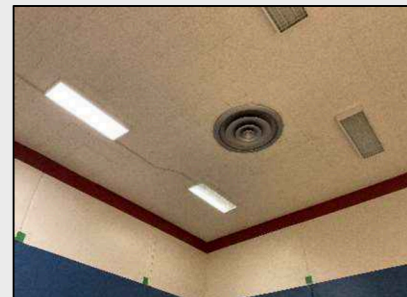
Replace Various Lighting Fixtures

Interior lighting consists of fluorescent fixtures. Exterior lighting is made up of a mixture of fluorescent and LED lights. Consider upgrading the fluorescent interior and exterior lighting to light emitting diode (LED) fixtures to reduce energy costs and maintenance needs.

FCAID-180134, FCAID-180135, FCAID-180136, FCAID-180137, FCAID-180139

Priority Level: 2
Estimated Cost: \$1,241,990
Remaining Life: 2 years
