POUDRE SCHOOL
DISTRICT
POUDRE GLOBAL
ACADEMY

FACILITY CONDITION ASSESSMENT

FORT COLLINS, CO

OCTOBER 2023

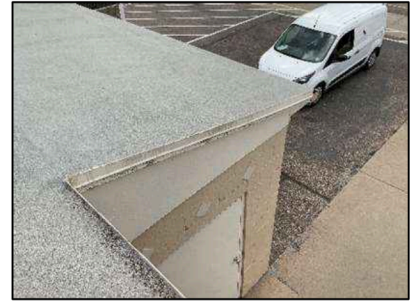
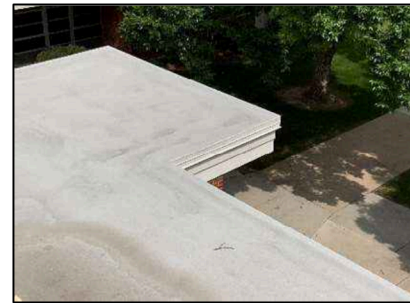
Replace Gutters and Metal Flashing

Gutters and Metal Flashing installed in approximately 1975 have now surpassed their industry life expectancy [REDACTED]. These roofing components should be replaced within the next year.

FCAID-460017, FCAID-460018

Priority Level: 2
Estimated Cost: \$16,310
Remaining Life: 1 year

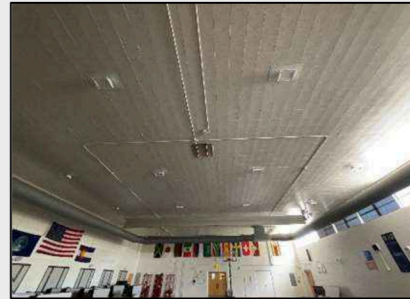
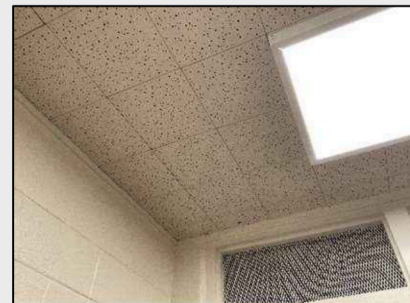
Replace 1957 Acoustic Ceiling Tile

[REDACTED]
[REDACTED]
[REDACTED] This acoustic tile should be replaced within the next year.

FCAID-460049

Priority Level: 1
Estimated Cost: \$44,360
Remaining Life: 1 year

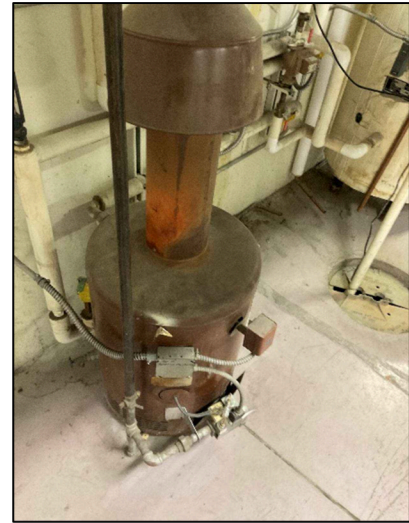
Replace the Gas Water Heater

Domestic hot water is provided by a natural gas fired water heater installed in 1979, [REDACTED] and should be replaced within the next year.

FCAID-460060

Priority Level: 2
Estimated Cost: \$14,350
Remaining Life: 1 year

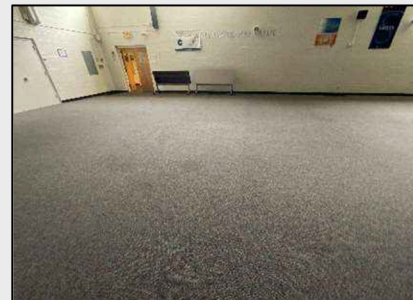
Replace 1996 Carpet

The carpeting that was installed in 1996 has surpassed its life expectancy [REDACTED] [REDACTED] It is recommended that these areas of carpet are replaced within the next year.

FCAID-460045

Priority Level: 3
Estimated Cost: \$77,530
Remaining Life: 1 year
