# POUDRE SCHOOL DISTRICT BETHKE ELEMENTARY SCHOOL

## FACILITY CONDITION ASSESSMENT

TIMNATH, CO  
OCTOBER 2023

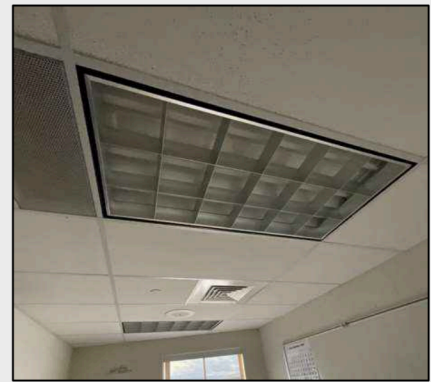
### 1. Replace outdated Lighting

A portion of the building's interior lighting utilizes fluorescent (T8) technology. This includes the classroom spaces, corridors, and administrative areas. Consider replacing these fixtures with light emitting diode (LED) fixtures to reduce the building's energy costs and maintenance needs. [REDACTED]

**Priority Level:** 2  
**Estimated Cost:** \$1,166,760  
**Remaining Life:** 2 Years

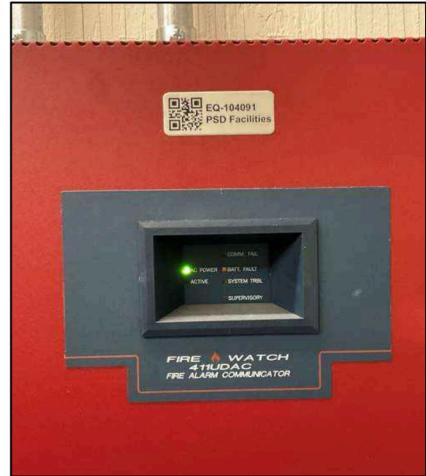
## 2. Update Fire Alarm System

The fire alarm system was installed when Bethke Elementary School was built in 2008,

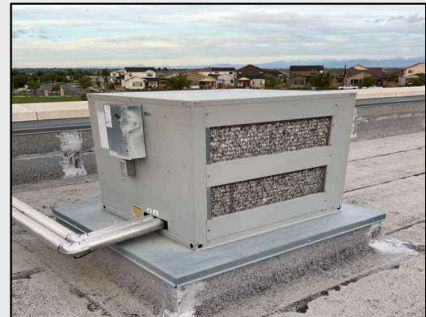
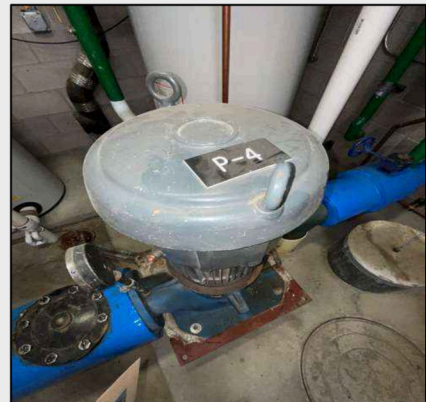
## 3. Replace outdated HVAC Units / Equipment

Multiple HVAC units are in need of replacement such as a Heat Pump, Condensing Unit, and multiple related HVAC Pumps.

**Priority Level:** 2  
**Estimated Cost:** \$70,880  
**Remaining Life:** 2 Years

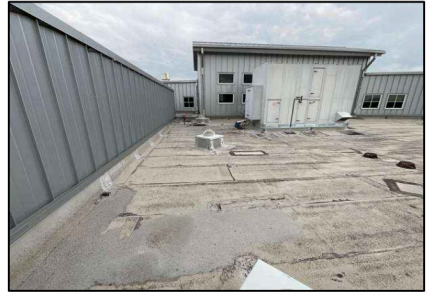
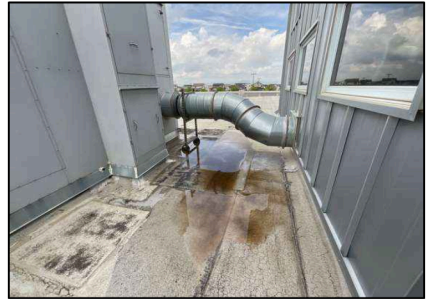
## 4. Granular Rolled Roofing / Asphalt is in poor condition

The granular rolled roofing is [REDACTED] with many areas completely bare of granules. Additional localized areas where ponding does occur during rains exists.

**Priority Level:** 2  
**Estimated Cost:** \$288,500  
**Remaining Life:** 2 Years

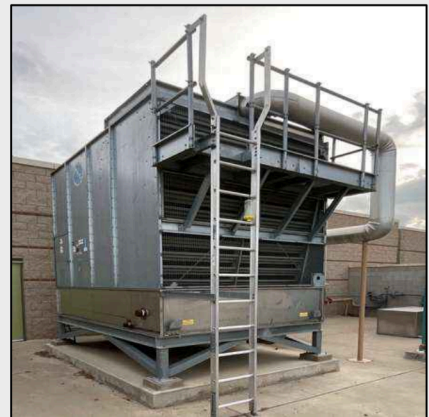
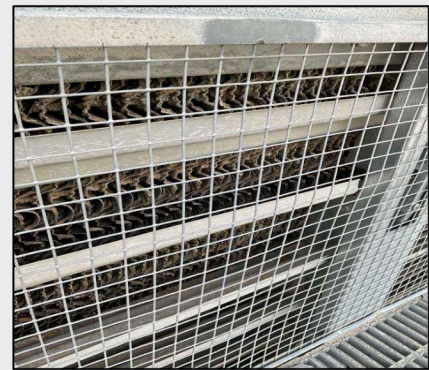
## 5. Replace outdated Cooling Tower

The main Cooling Tower is a 200 Ton unit and is nearing its anticipated life expectancy. [REDACTED]

**Priority Level:** 3  
**Estimated Cost:** \$161,090  
**Remaining Life:** 3 Years
