POUDRE SCHOOL DISTRICT

BACON ELEMENTARY SCHOOL

FACILITY CONDITION ASSESSMENT

OCTOBER 2023

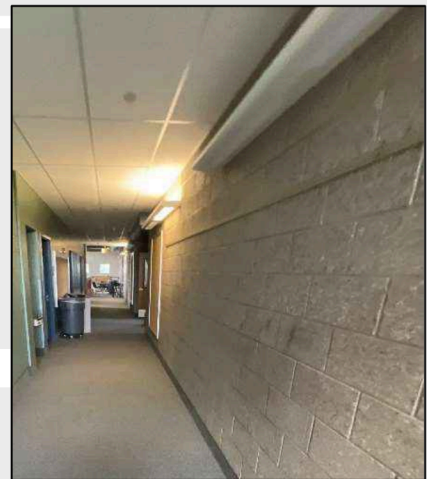
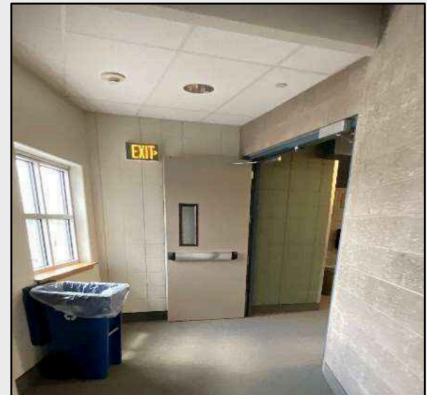
1. Replace outdated Lighting

A portion of the building's interior lighting utilizes fluorescent (T8) technology. This includes the classroom spaces, corridors, and administrative areas. Consider replacing these fixtures with light emitting diode (LED) fixtures to reduce the building's energy costs and maintenance needs. Additionally, the emergency back-up lighting is 20 years

- Interior Lighting, Fluorescent (FCAID-010124)
- Emergency Back-up Lighting (FCAID-010122)

Priority Level: 2
Estimated Cost: \$1,248,520
Remaining Life: 5 years

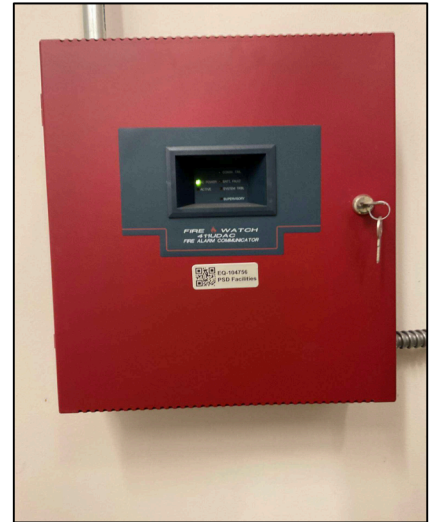
2. Update Fire Alarm System

The fire alarm system was installed when Bacon Elementary School was built in 2011,

- Fire Alarm System (FCAID-010121)

Priority Level: 2
Estimated Cost: \$508,680
Remaining Life: 5 Years

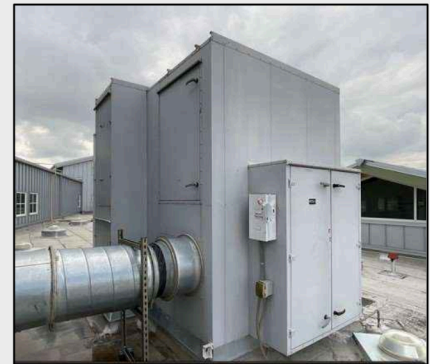
3. Replace outdated HVAC (RTU / Package Units)

Eight (8) outdated HVAC (RTU / Package Units) need replacement [REDACTED]

- RTU-1 (FCAID-010064)
- RTU-5 (FCAID-010068)
- RTU-4 (FCAID-010067)
- RTU-3 (FCAID-010066)
- RTU-2 (FCAID-010065)
- RTU-6 (FCAID-010069)
- CLRTU-2 (FCAID-010063)
- CLRTU-1 (FCAID-010062)

Priority Level: 1
Estimated Cost: \$727,230
Remaining Life: 3 Years
