# POUDRE SCHOOL DISTRICT

# CACHE LA POUUDRE ELEMENTARY SCHOOL

## FACILITY CONDITION ASSESSMENT

OCTOBER 2023

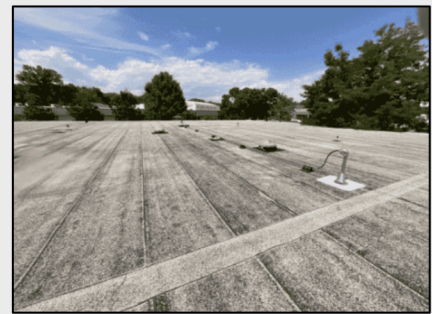
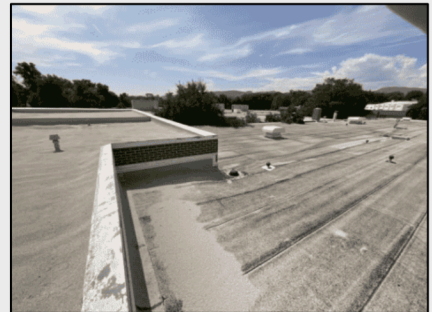
##### Replace Rolled Asphalt Roof

The rolled asphalt roof was installed in 1992 making it 6 years past expected life. [REDACTED]  
[REDACTED] Recommend replacement within the year.

**Priority Level:** 2  
**Estimated Cost:** \$118,990  
**Remaining Life:** 1 year

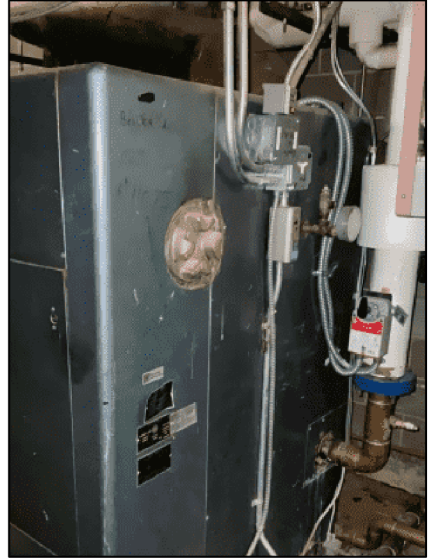
## Replace Boiler-2

Boiler-2, a 1,080 MBH fuel-fired boiler, dates to 1973 install and is 15 years past expected life. Recommend replacement prior to 2024-2025 heating season.

**Priority Level:** 2  
**Estimated Cost:** \$93,980  
**Remaining Life:** 1 year

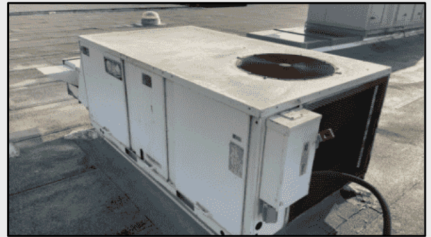
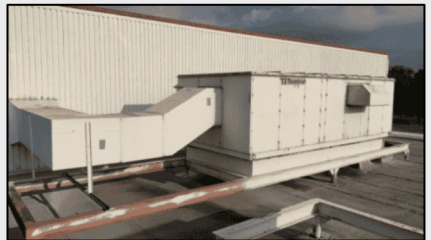
## Replace RTU-6 & RTU-4

Both RTU-6 and RTU-4 were installed in 1993 [REDACTED]  
Recommend that RTU-6 be replaced within the year and RTU-4 be replaced within two years.

**Priority Level:** 2  
**Estimated Cost:** \$152,060  
**Remaining Life:** 1-2 years

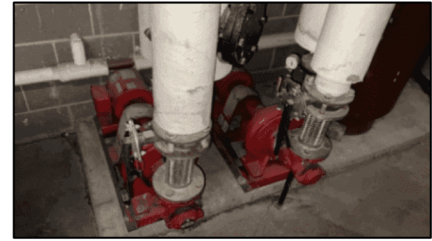
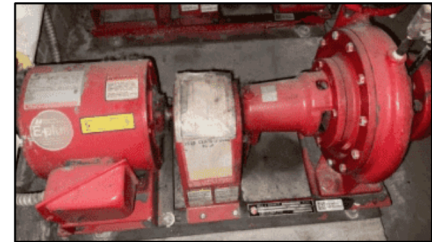
## Replace P-1 & P-2

P-1 and P-2, 3 Hp pumps serving the Heating Water System, [REDACTED] and are estimated to require replacement within two years.

**Priority Level:** 2  
**Estimated Cost:** \$23,440  
**Remaining Life:** 2 years

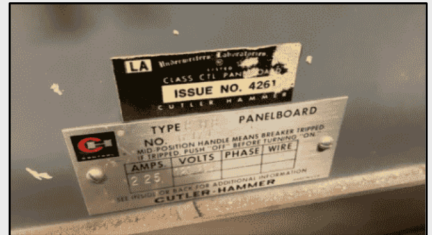
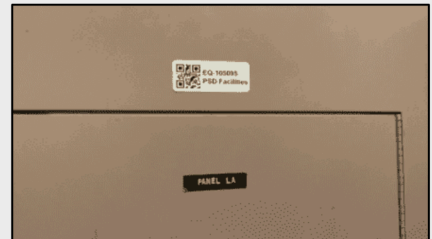
## Replace Panel -LA

[REDACTED] Replace within two years.

**Priority Level:** 2  
**Estimated Cost:** \$3,270  
**Remaining Life:** 1 year
