The contents of this report present the results of the Facility Condition Assessment (FCA) performed at Olander School for Project Based Learning ES within the Poudre School District (PSD) on August 23, 2023. PSD intends to utilize the findings of this report to inform both capital and operating budgets, prioritize maintenance efforts, and optimize planning processes as replacements and upgrades of assets and facility systems become necessary in the future.

Olander School for Project Based Learning ES

Condition Assessment

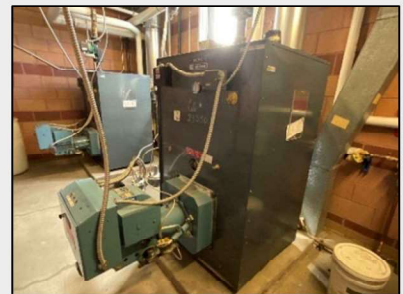
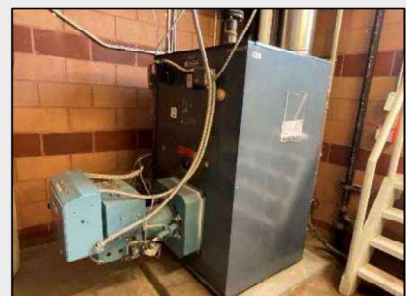
Replace Boilers

The two existing boilers serving the school's hot water system, are nearing the end of their life expectancy and are anticipated to need replacement within the next five years.

FCAID-400038, FCAID-400039

Priority Level:	2
Estimated Cost:	\$157,260
Remaining Life:	5 Years

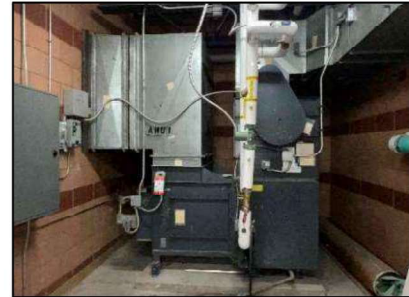
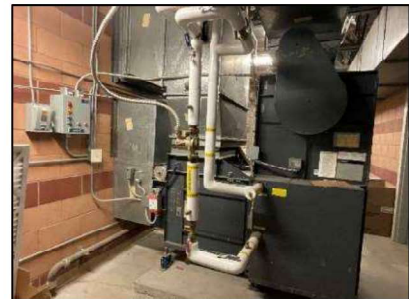
Replace AHU-1 and AHU-2

The two air handling units in the mechanical mezzanine space, AHU-1 and AHU-2, have surpassed their industry life expectancy by nearly ten years, and are in somewhat poor condition. These two units should be replaced within the next three years.

FCAID-400035, FCAID-400036

Priority Level: 1
Estimated Cost: \$195,530
Remaining Life: 3 Years

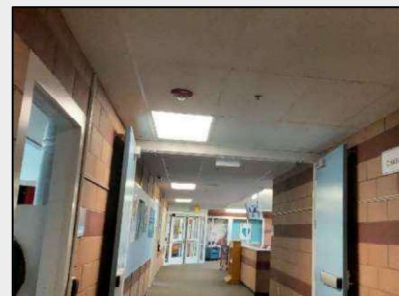
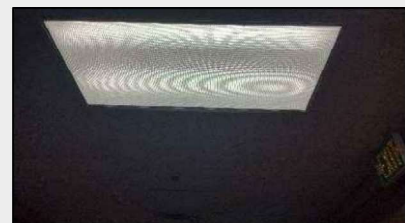
Replace Interior Fluorescent Lighting

The interior lighting fixtures are nearing the end of their recommended lifespan. Consider upgrading the interior and exterior lighting to light emitting diode (LED) fixtures to reduce energy costs and maintenance needs.

FCAID-400131

Priority Level: 2
Estimated Cost: \$786,690
Remaining Life: 4 Years

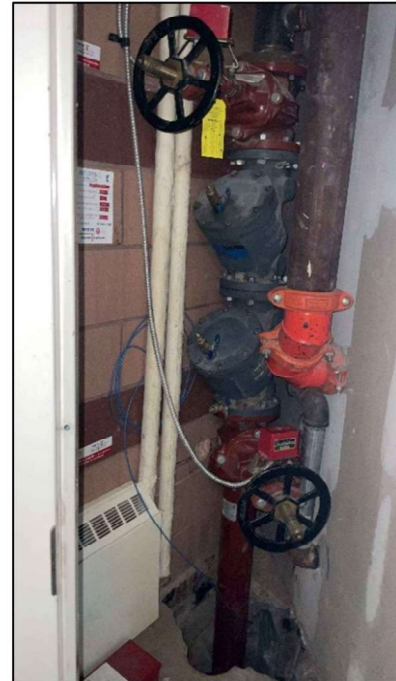
Replace Wet Sprinkler System

The wet sprinkler system was estimated to have been installed during original construction, this would indicate that it is nearing the end of its industry life expectancy and should be replaced within the next six years.

FCAID-400128

Priority Level: 2
Estimated Cost: \$891,000
Remaining Life: 6 Years

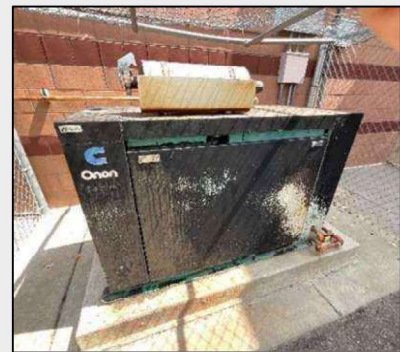
Replace Emergency Generator

The emergency generator is in poor condition and has surpassed its industry life expectancy. This asset should be replaced within the next four years.

FCAID-400151

Priority Level: 2
Estimated Cost: \$28,150
Remaining Life: 4 Years
