POUDRE SCHOOL DISTRICT DUNN ELEMENTARY SCHOOL

FACILITY CONDITION ASSESSMENT

FORT COLLINS, CO

OCTOBER 2023

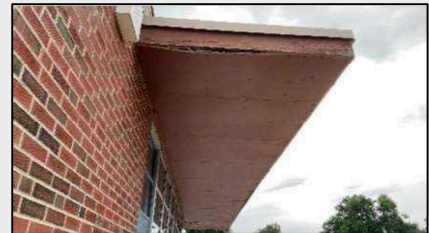
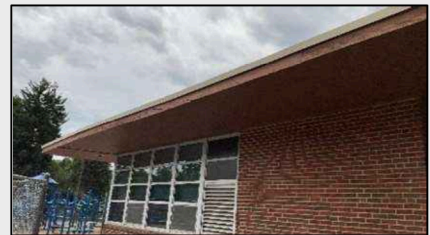
Replace Wood Soffit

The wood soffit [REDACTED] should be replaced within the next year.

Priority Level:	2
Estimated Cost:	\$5,120
Remaining Life:	1 year

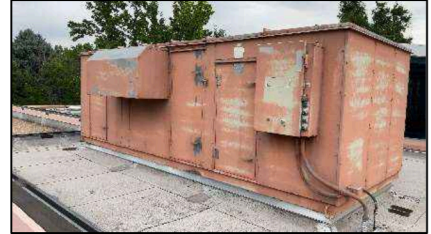
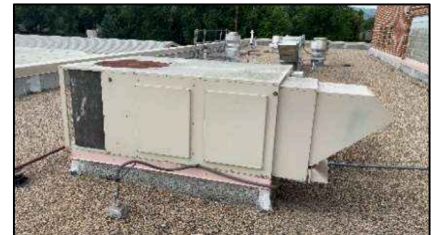
Replace RTU-1 and RTU-2

RTU-1 and RTU-2, which serve various classrooms and the administration area, have surpassed their life expectancies by over 15 years and [REDACTED] should be replaced within the next two years.

Priority Level: 2
Estimated Cost: \$158,380
Remaining Life: 2 years

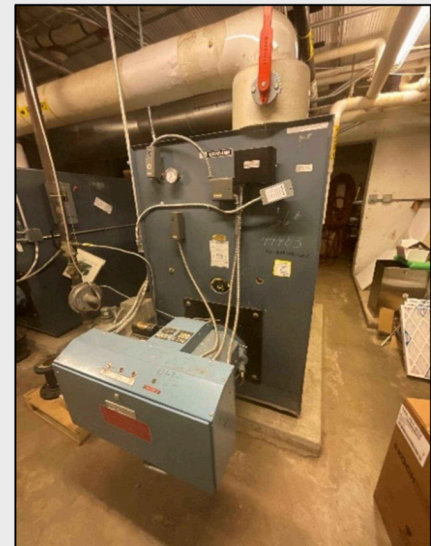
Replace Boilers

The two boilers in serving the hot water system at Dunn Elementary School, are nearing the end of their life expectancy and are anticipated to need replacement within the next four years.

Priority Level: 2
Estimated Cost: \$231,160
Remaining Life: 4 years

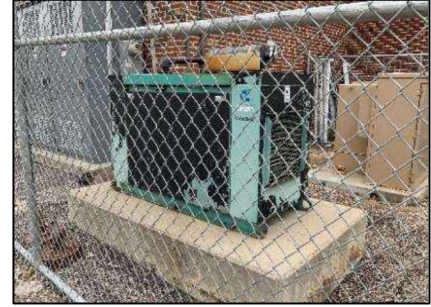
Replace Emergency Generator

The emergency generator has surpassed its industry life expectancy and [REDACTED] [REDACTED] is recommended the the generator be replaced within the next three years.

Priority Level: 2
Estimated Cost: \$22,400
Remaining Life: 3 years

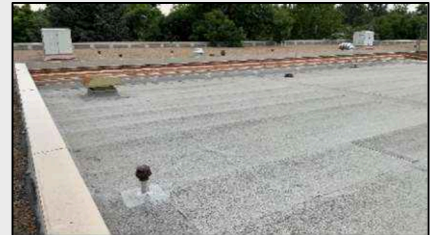
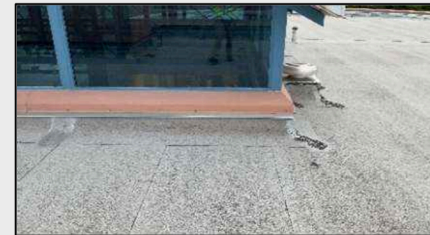
Replace 2006 Asphalt Roofing

The area of roof with rolled asphalt installed in 2006 is [REDACTED] nearing the end of its life expectancy. This roofing is anticipated to need replacement within the next two years.

Priority Level: 2
Estimated Cost: \$26,780
Remaining Life: 2 years
