POUDRE SCHOOL DISTRICT

SHEPARDSON STEM ELEMENTARY SCHOOL

FACILITY CONDITION ASSESSMENT

OCTOBER 2023

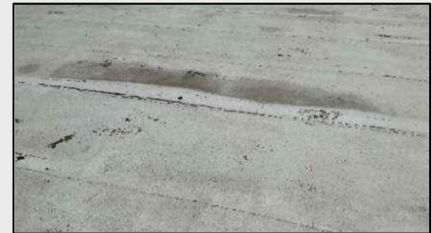
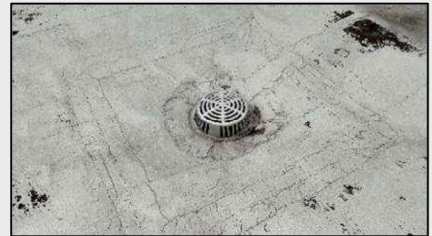
FCAID-520012

Replace or Recoat Coated Asphalt Roofing

The coated asphalt roofing is [REDACTED] reaching the end of its industry life expectancy. The roof will need to be recoated or replaced soon.

Priority Level: 2
Estimated Cost: \$339,000
Remaining Life: 6 years
