**RED FEATHER LAKES  
ELEMENTARY**

POUDRE SCHOOL  
DISTRICT

FACILITY CONDITION ASSESSMENT

OCTOBER 2023

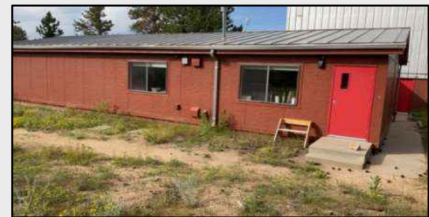
##### Replace 1997 Exterior Windows

[REDACTED] Recommend replacement of 185 SF of windows within two years.

Priority Level:	2
Estimated Cost:	\$13,740
Remaining Life:	2 Years

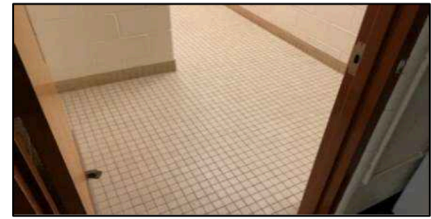
## Replace 1985 Ceramic Tile Flooring

The 1985 ceramic tile flooring located in the restrooms is 13 years past expected life. Replace within three years.

**Priority Level:** 3  
**Estimated Cost:** \$5,880  
**Remaining Life:** 3 Years

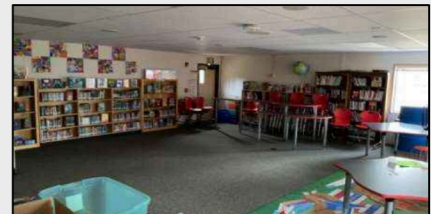
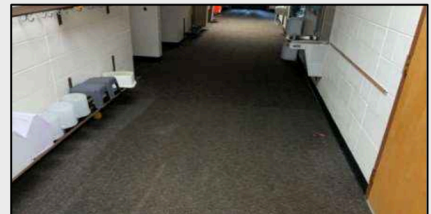
## Replace 2013 Carpeting

Though replaced in 2013, the carpeting will be due for replacement again in approximately three years.

**Priority Level:** 3  
**Estimated Cost:** \$109,140  
**Remaining Life:** 3 Years
