POUDRE SCHOOL
DISTRICT
WEBBER MIDDLE
SCHOOL

FACILITY CONDITION ASSESSMENT

FORT COLLINS, CO

OCTOBER 2023

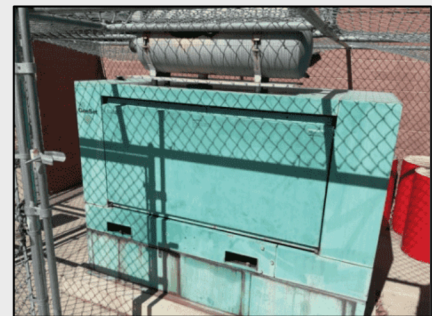
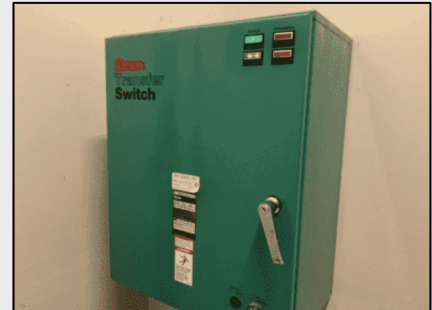
Replace Back-Up Generator & ATS-1

FCAID-600204, FCAID-600203

Priority Level:	2
Estimated Cost:	\$32,490
Remaining Life:	1-5 Years

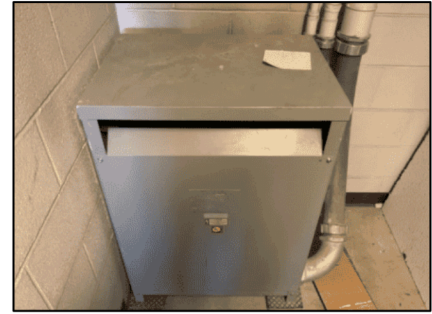
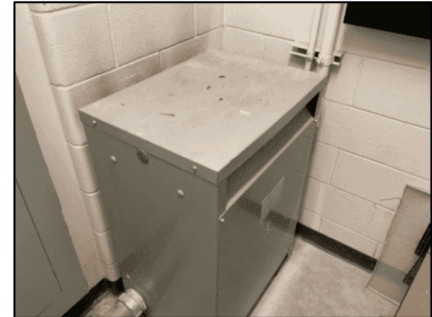
Replace Transformers D23 & L3

Transformers D23 and L3 were [REDACTED] Recommend replacement within the year.

FCAID-600233, FCAID-600235

Priority Level: 2
Estimated Cost: \$16,380
Remaining Life: 1 Year

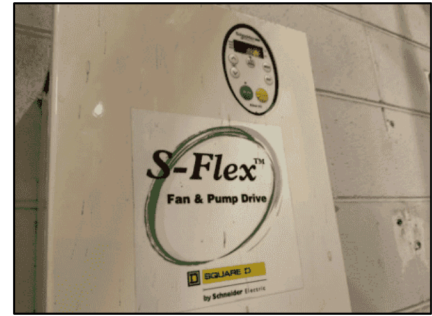
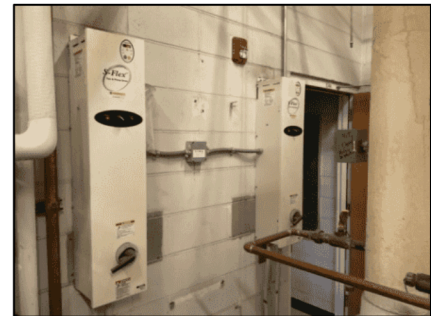
Replace VFD-HWP-1, VFD-HWP-2, VFD-RTU-11

VFD-HWP-1, VFD-HWP-2, and VFD-RTU-11 are original 1990-built VFDs that are 14 years past expected life. [REDACTED]. Recommend replacement within two years.

FCAID-600238, FCAID-600239, FCAID-600240

Priority Level: 2
Estimated Cost: \$16,890
Remaining Life: 2 Years

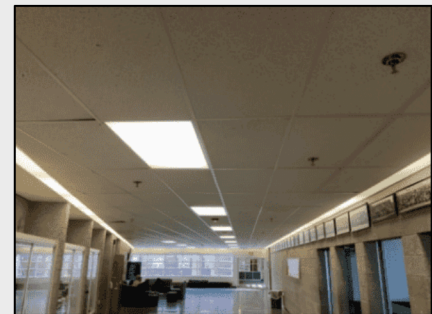
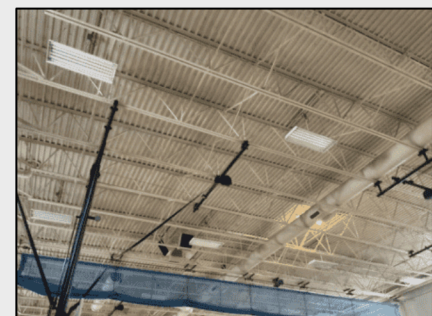
Replace Interior Fluorescent Light Fixtures

The entirety of the interior consists of 1990 fluorescent lighting fixtures that are 13 years past expected life. Recommend replacement with LED fixtures throughout within two years

FCAID-600208

Priority Level: 2
Estimated Cost: \$1,879,870
Remaining Life: 2 Years
