POUDRE SCHOOL
DISTRICT
LINCOLN MIDDLE
SCHOOL

FACILITY CONDITION ASSESSMENT

FORT COLLINS, CO

OCTOBER 2023

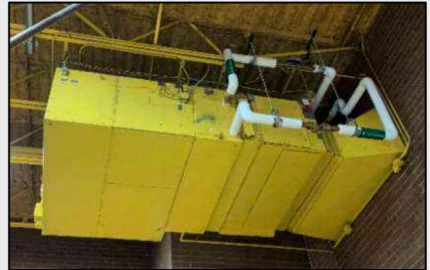
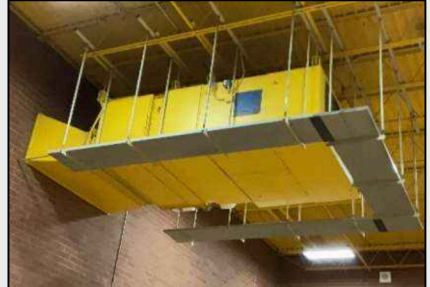
Replace Air Handling Units

The three air handling units serving the gym and mini gym areas [REDACTED] appear to have been installed during original construction in 1974. These units have surpassed their industry life expectancies and should be replaced within the next five years.

Priority Level:	2
Estimated Cost:	\$255,960
Remaining Life:	5 years

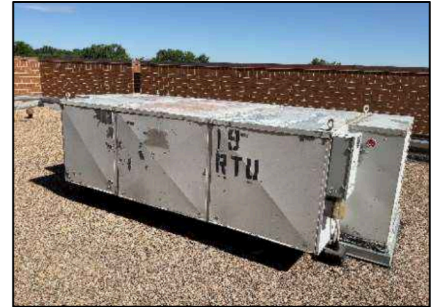
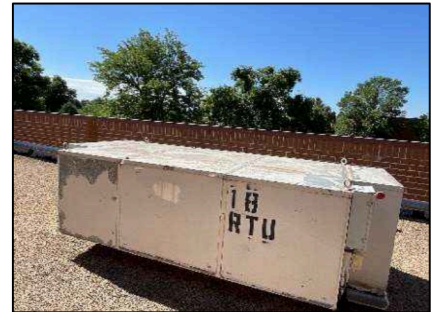
Replace Rooftop Units

RTU-18 and RTU-19 serving the locker room areas [REDACTED] have surpassed their industry life expectancies and should be replaced within the next four years.

Priority Level: 2
Estimated Cost: \$69,970
Remaining Life: 4 years

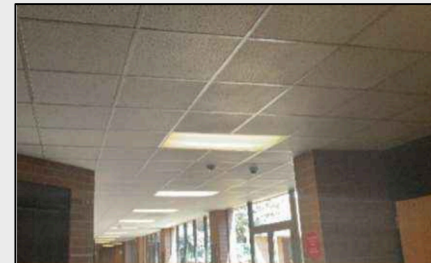
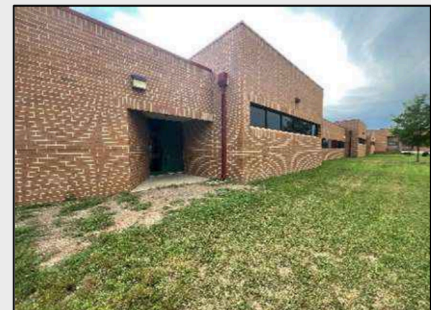
Replace Lighting Fixtures

Interior lighting consists of mostly fluorescent fixtures. Exterior lighting is made up of a mixture of fluorescent, incandescent, and LED lights [REDACTED]. Consider upgrading the interior and exterior lighting to light emitting diode (LED) fixtures to reduce energy costs and maintenance needs.

Priority Level: 2
Estimated Cost: \$1,986,740
Remaining Life: 2-4 years

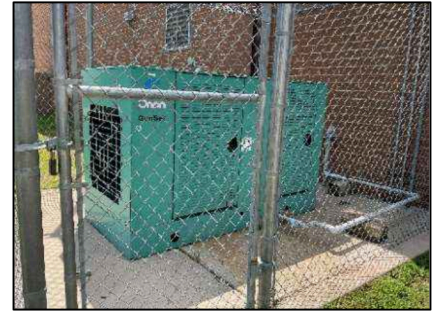
Replace Emergency Generator

The emergency generator has surpassed its industry life expectancy and is anticipated to need replacement within the next six years

Priority Level: 2
Estimated Cost: \$42,220
Remaining Life: 6 years

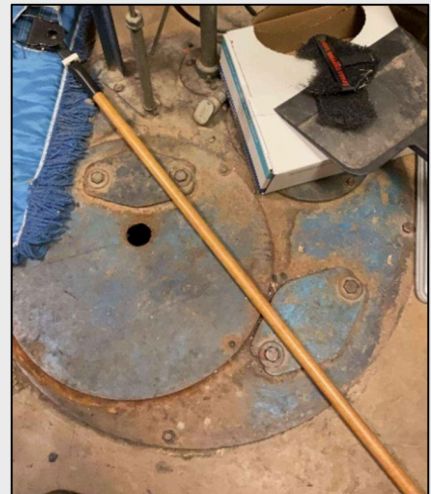
Replace Sump Pump

The sump pump is estimated to have been installed in approximately 1974 and has surpassed its life expectancy and is anticipated to need replacement within the next two years.

Priority Level: 2
Estimated Cost: \$8,300
Remaining Life: 2 years
