# POUDRE SCHOOL DISTRICT

# WELLINGTON MIDDLE-HIGH SCHOOL

## FACILITY CONDITION ASSESSMENT

OCTOBER 2023

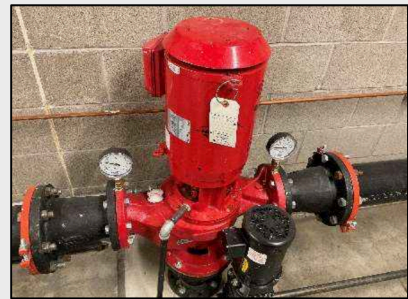
#### Replace Fire Pump 1

Although Wellington Middle/High School is a recently constructed building, fire pump 1 is [REDACTED] is recommended that this pump be replaced within two years.

Priority Level:	1
Estimated Cost:	\$24,640
Remaining Life:	2 Years

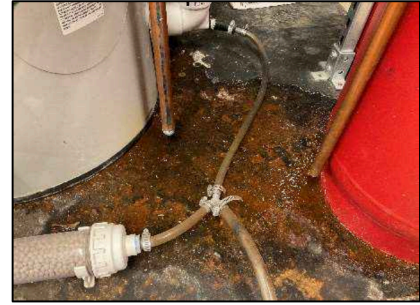
## Replace WH-4

Although Wellington Middle/High School is a recently constructed building, WH-4 was identified to have a leak [REDACTED]. It is recommended that this water heater be replaced within two years.

**Priority Level:** 2  
**Estimated Cost:** \$30,160  
**Remaining Life:** 2 Years

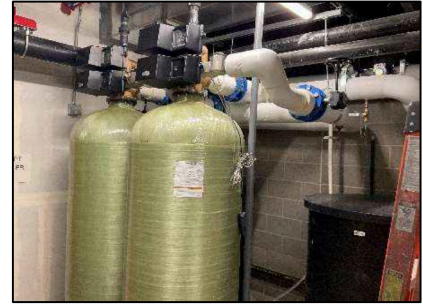
## Water Softeners

The water softeners have been taken offline due to [REDACTED] [REDACTED]. Unsafe levels of copper have been detected in the DCWS. To ensure longevity of the school's domestic water systems, we recommend that an entirely new comprehensive water treatment system be installed that can treat domestic cold water for metals and other contaminants.

<b>Priority Level:</b>	2
<b>Estimated Cost:</b>	TBD
<b>Remaining Life:</b>	N/A
