Roof Condition Report

Polaris Expeditionary Learning School 1905 Orchard Place Fort Collins, Colorado

2016

Job Number: 8523-A

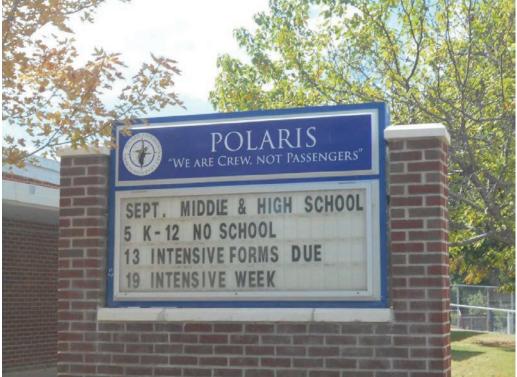
Photo 1

Roof Section A

Polaris Expeditionary Learning.

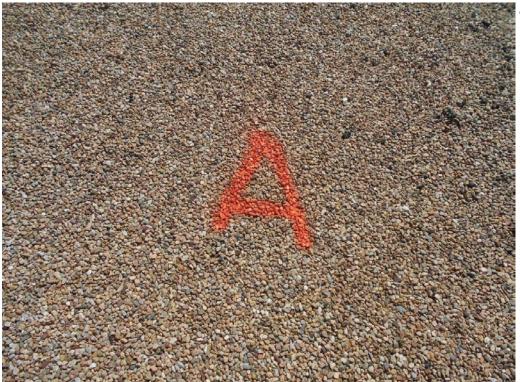
Photo 2

Built-up roof, gravel surface.

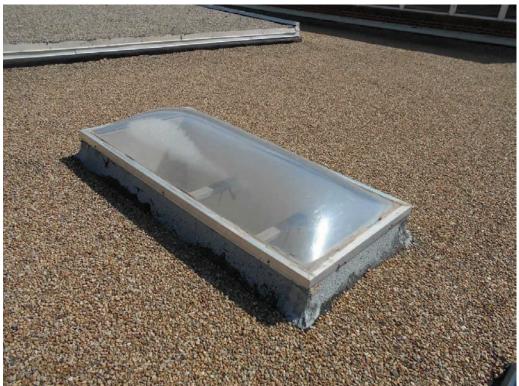
Photo 3

View of one of the skylights. The skylight has been repaired with caulking. It may be recommended that new skylights be installed during the roof replacement.

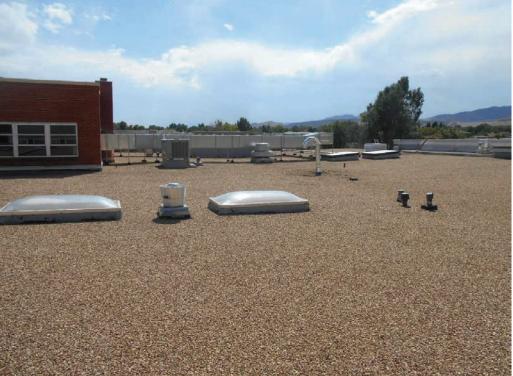
Photo 4

View of Section A.

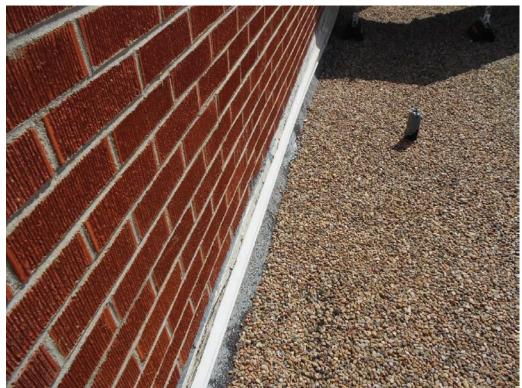
Photo 5

The caulking on top of the reglet flashing is deteriorating. The reglet will be removed and a new surface-mounted counterflashing will be installed during the roof replacement.

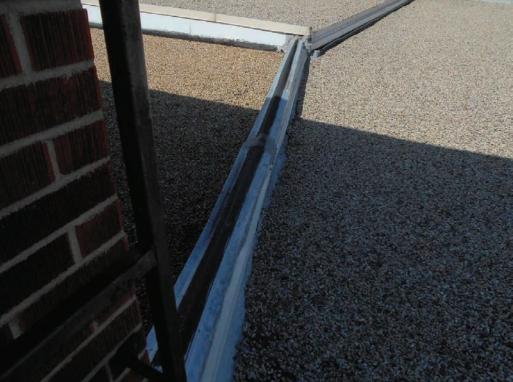
Photo 6

View of the expansion joint. The expansion joint will be replaced during the roof replacement.

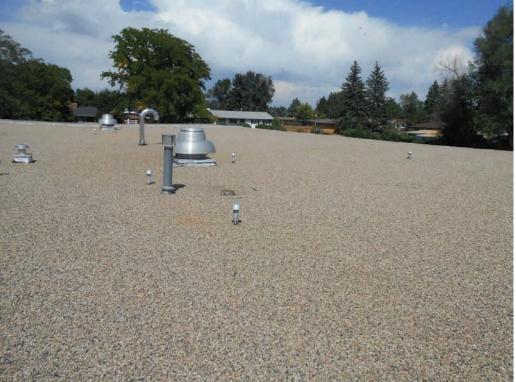
Photo 8

View of east area of Section A.

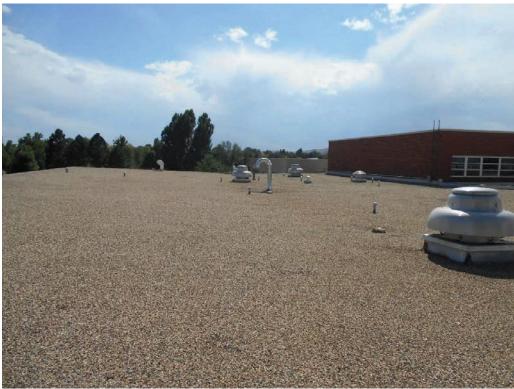
Photo 9

View of the east area of Section A looking south.

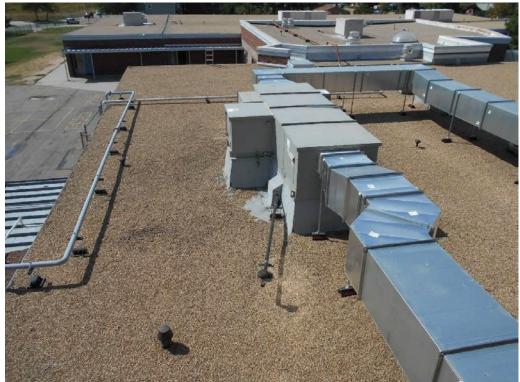
Photo 10

Overview of Section A. This is a new curb that was installed in the summer of 2016.

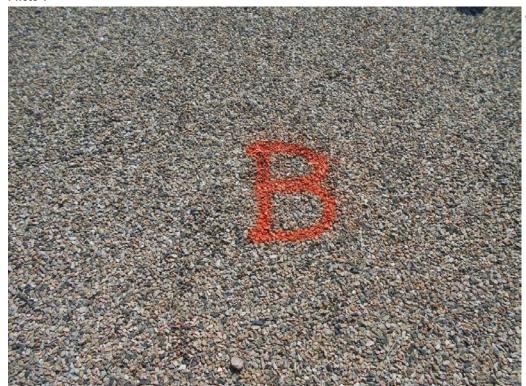
Photo 1

Notes: This roof has reached the end of its service life. A replacement is scheduled for 2017. A tear off to the deck is recommended for this roof.

Built-up roof, gravel surface.

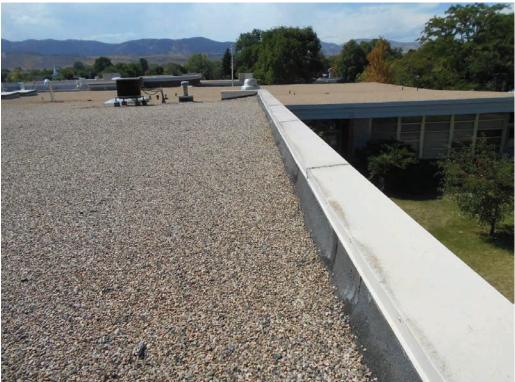
Photo 2

View of Section B. This is located on the north side of the school. It is recommended the metal cap be replaced during the roof replacement.

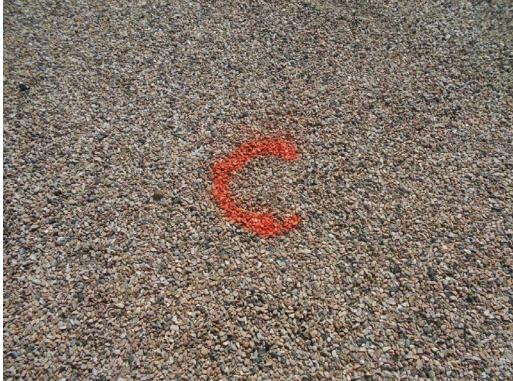
Photo 1

Notes: This roof has reached the end of its service life. A replacement is scheduled for 2017. A tear off of the existing roof is recommended for this roof.

Roof Section C

Gymnasium roof.

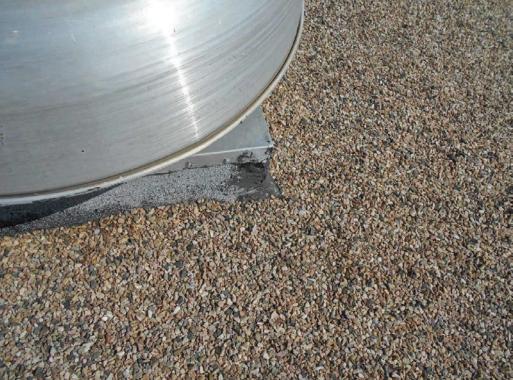
Photo 2

Open corner at a bell fan curb.

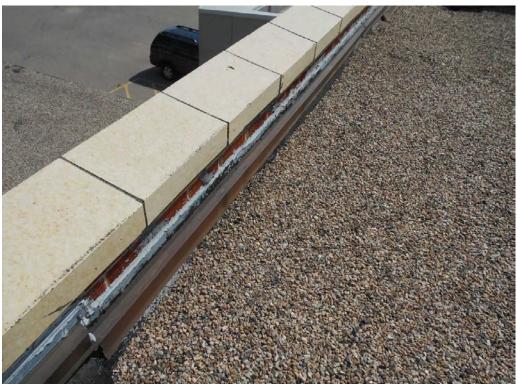
Photo 3

Caulking is deteriorating at the counterflashing.

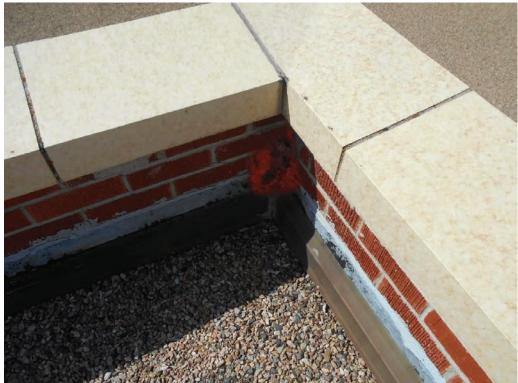
Photo 5

Gymnasium roof, the caulking is cracking open in this corner.

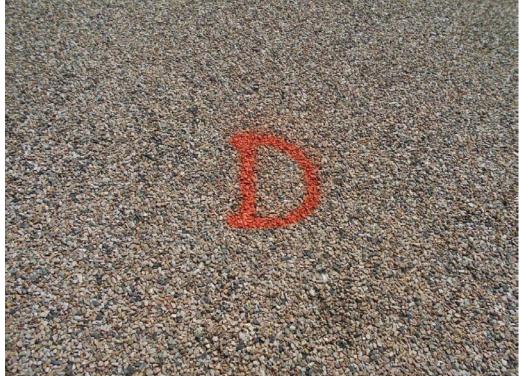
Photo 1

Notes: The roof has reached the end of its service life. A replacement is scheduled for 2017. It is recommended this roof be torn off to the deck.

Roof Section D

Built-up roof, gravel surface.

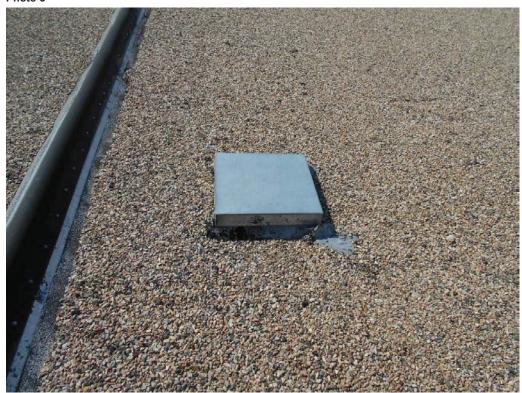
Photo 3

It is recommended that any obsolete penetrations be removed during the roof replacement.

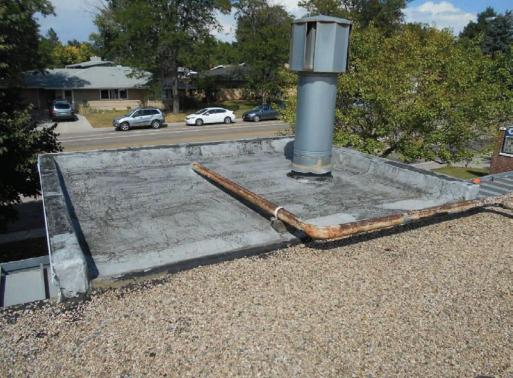
Photo 4

North side of Section D. Smooth coat built-up roof.

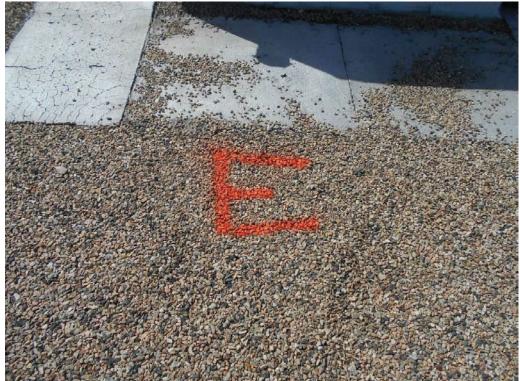
Photo 1

Notes: This roof has reached the end of its service life. A replacement is scheduled for 2017. It is recommended this roof be torn off to the deck.

Roof Section E

South end of Section E.

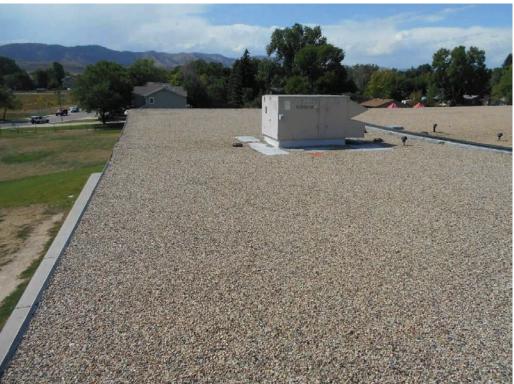
Photo 2

View of Section E looking west.

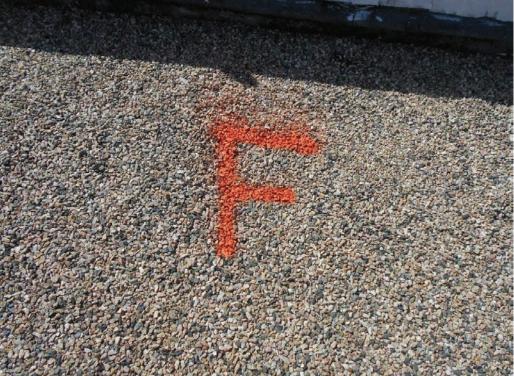
Photo 1

Notes: The roof has reached the end of its service life. A replacement is scheduled for 2017. This roof will need to be torn off to the deck.

Roof Section F

View of Section F.

Built-up roof, gravel surface.

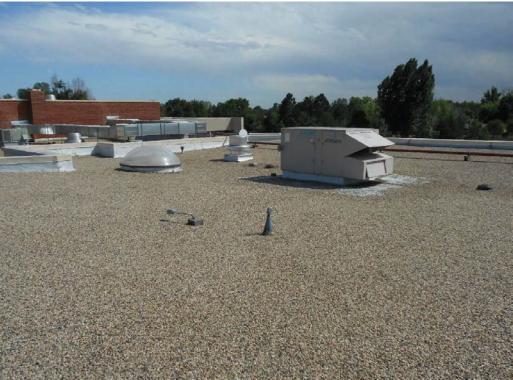
Photo 2

Another view of Section F. This area is recommended

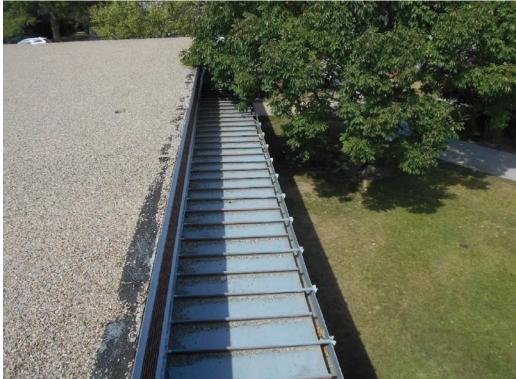
Photo 1

Notes: The roofs on the walk-way canopy have reached the end of their service life. A replacement is recommended in 2017. The replacement cost is based on an overlay over the existing roof. Approval from a structural engineer will be required for the proposed roof system.

Roof Section G

Metal canopy.

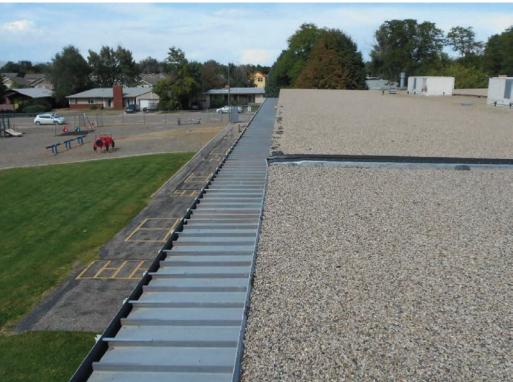
Photo 2

West area of the canopy looking north.

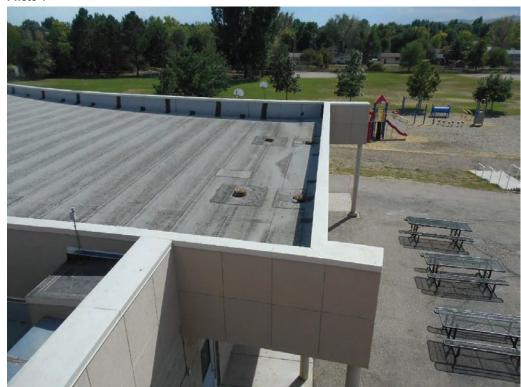
Photo 1

Roof Section H

The roof is in good condition. No repairs are recommended.

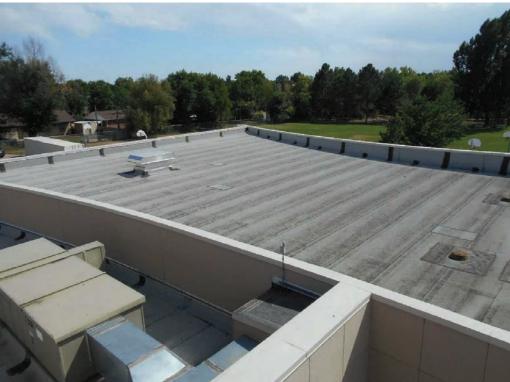
Photo 2

View of Section H looking southeast. The roof is in good condition.

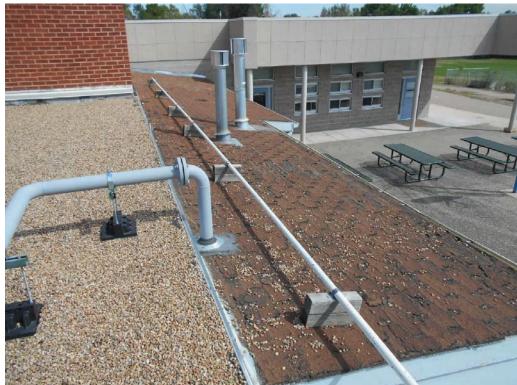
Photo 1

Roof Section I

The shingles have reached the end of their service life. A single-ply roof system is recommended for this area.

Notes: The shingles have reached the end of their service life. A replacement is scheduled for 2017. When reroofed a single ply TPO roof is recommended.
